# **CONDITION REPORT**

## **FOR HOROWHENUA DISTRICT COUNCIL CIVIC BUILDING**

**AT  
126 – 148 OXFORD STREET  
LEVIN, 5510**

**REPORT NO. BC068**

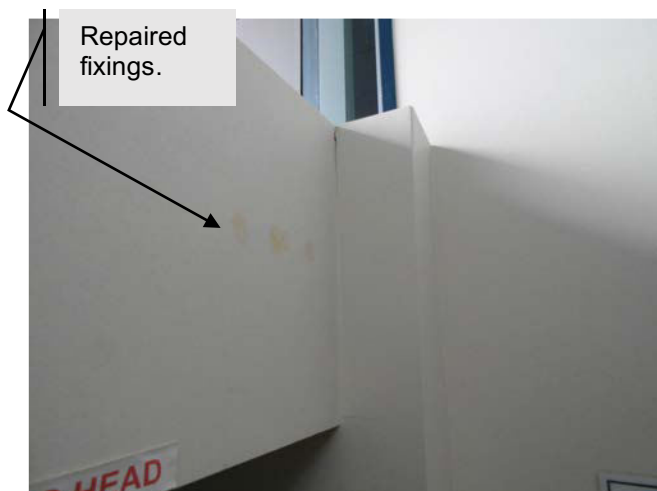
Photo 1

2.01.02 Cracking was noted at the junction of the plasterboard above the stair adjacent to the Social Room where it abutted a column (refer to Photos 1 and 2). This cracking is likely to be due to some movement of the building either caused by thermal movement or recent earthquakes, but is not considered to be significant. It was noted however that the fixings of the plasterboard had 'popped' and been repaired on this section in the past and when this area is redecorated the cracking evident should be repaired.

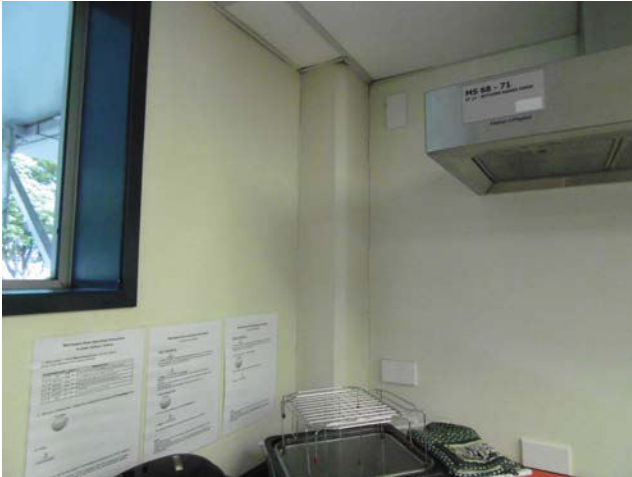
Photo 3

2.01.03 Further cracking at this level was also noted at the junction of the plasterboard wall between the Kitchen and Social Room with the structural column on the external wall (refer to Photos 3 and 4). This again illustrates some movement between the different elements and although not considered significant will require repair. Additional areas of hairline shrinkage cracking were also noted in the corners of other rooms at this Mezzanine level.

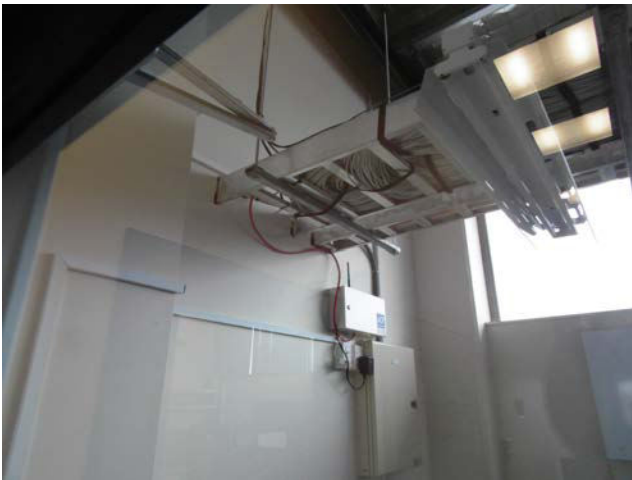
Photo 5

- 2.01.04 Within the Server Room at the far end of the Mezzanine level it was noted that cable trays were installed above the server, which were supported between the walls. Where these abut the stair wall, there were however open gaps through which some of the cables penetrated without any protection and this may therefore affect the fireproof integrity of this wall (refer to Photos 5 and 6).

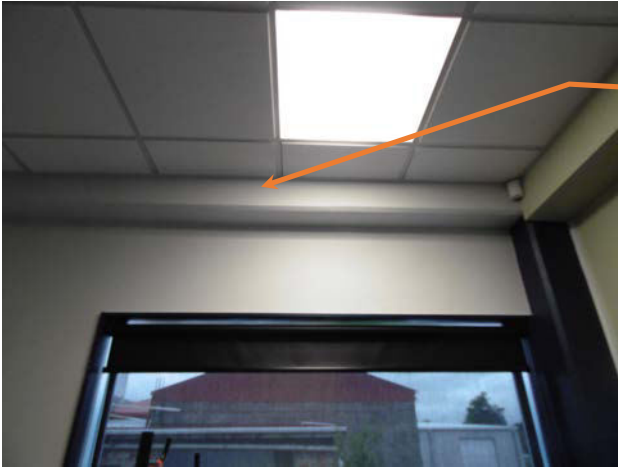
Photo 7

- 2.01.05 At ground level within the Offices some additional cracking was noted. Within Office 146 a crack was noted to the beam on the south-west side of the building approximately 1.7m from the fire exit door (refer to Photos 7 and 8), with additional cracking noted along the same elevation wall beneath the window opening in Office 148 (refer to Photo 9). Some cracking and loose plaster was also noted at the junction of the internal partition to Office 147 with the steel frame (refer to Photo 10). Again these are not considered to be significant, but are signs of general movement that has occurred to the building since its construction and will require repair and monitoring for further deterioration.

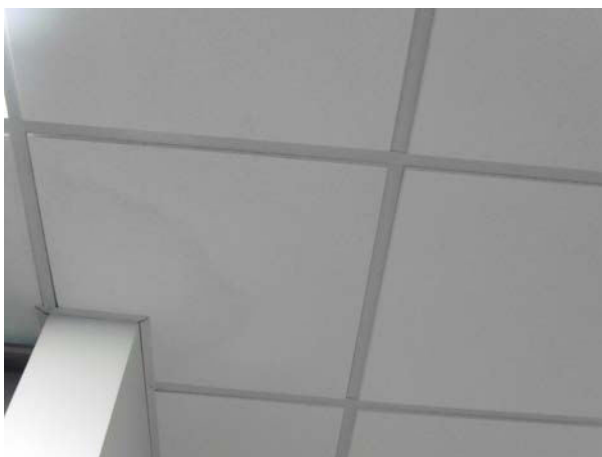
Photo 11

2.01.06 Within Office 146 some staining was also evident to the ceiling adjacent to the north west elevation and beneath the terrace area on the Mezzanine level above (refer to Photo 11). An inspection of the column adjacent to the window in this location revealed drip runs from the ceiling level down the column (refer to Photo 12) and staining and cracking of the column at the base (refer to Photo 13). This was repeated on the opposing side of the window (refer to Photos 14 and 15) and confirms therefore that moisture has penetrated from above, it is suspected through the junction of the terrace waterproofing with the structural elements above this area. It is recommended therefore that further investigation is undertaken regarding the cause of this leak to ensure that it is rectified effectively.

- 3.04 Further moisture entry affecting the Civic Building was noted within Office 146, where staining was noted to either side of the window on the north east facing elevation. This Office is beneath the Terrace at the Mezzanine level and further investigation to confirm the location of moisture entry would be recommended to remediate this issue.

3. Undertake further investigation to identify the cause of moisture ingress from the Terrace level which is affecting Office 146 beneath it, rectify cause and repair affected areas.

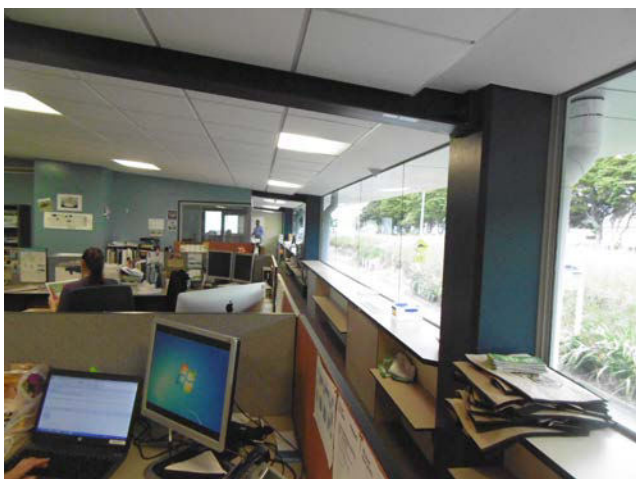
Photo 16

- 2.01.07 Within Office 136 there was evidence of moisture entry where cracking and deterioration was noted to the ceiling and the custom wood shelving has warped (refer to Photos 16 – 18). This moisture entry appears to be due to a leak from the internal gutter provided almost directly above this area and further investigation in respect of the cause and remedial works necessary should be undertaken to resolve it.

- 3.05 Within Office 136 damage is evident to the ceiling and the custom wood shelving beneath the window on the south east elevation. This is almost directly beneath the location of the internal gutter at roof level and further investigation at that level would be recommended to identify the cause and to allow this to be rectified.

4. Undertake further investigation into the cause of the leak affecting Office 136. This investigation will involve the hire of a hoist or erection of scaffold or edge protection to the roof for health and safety purposes to allow an inspection of the internal gutter to the main roof to be undertaken. Once the cause is identified repairs should be undertaken to repair the affected areas.

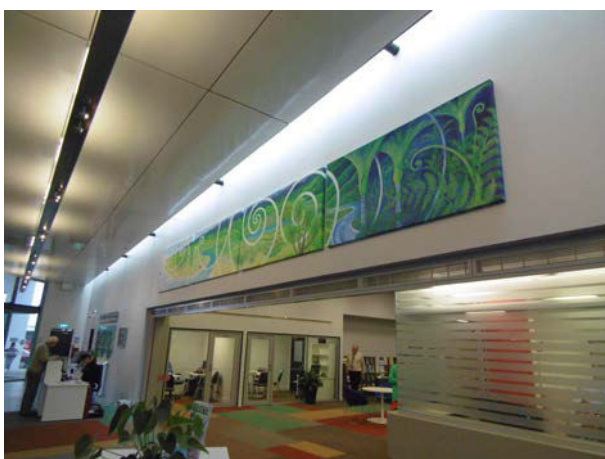
Photo 19

2.01.08 Further signs of moisture and cracking to the walls was noted within the Public Entrance Foyer. Above the entrance to Area 116 some moisture runs were noted to the wall at the time of our inspection either due to moisture entry or condensate forming on the underside of the glazing to the roof above this area (refer to Photos 19 and 20). Some cracking was also noted adjacent to the opening (refer to Photo 21).

5. Undertake further investigation into the cause of the drips affecting the Public Entrance Foyer to confirm the extent of remediation works required.

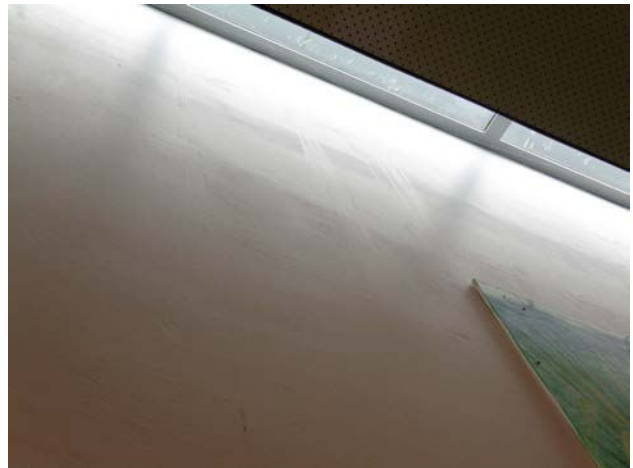
Photo 22

- 2.01.09 On the opposing side of the Public Entrance Foyer further moisture stain runs were noted (refer to Photos 22 – 24). These appear however to be due to moisture ingress rather than condensate and it would therefore be recommended that a more detailed inspection be undertaken to confirm their cause. This will involve inspecting the detailing of the junctions of the glazed lights and roof above this area, which was not accessible at the time of our inspection.

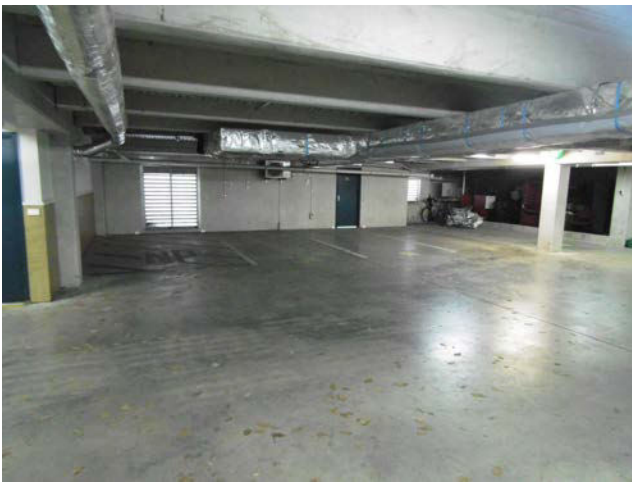
Photo 25

- 2.01.11 Cracking was evident adjacent to the saw cuts provided to the concrete slab forming the Car Park floor as control joints to control the amount of cracking that occurs (refer to Photos 25 – 27). These cracks have formed where they are expected at or adjacent to the weak points formed by the saw cuts. However, it was noted that the frequency of the saw cuts was not as per the design drawings, which showed them running perpendicular to all columns and to the centre of the entrance opening area at the south western end (refer to Photo 28). This lack of saw cuts may have increased the amount of cracking that has occurred in those areas.

1. Undertake repairs to cracking evident within floor slab at Basement level in accordance with Engineer's recommendations and saw cut additional control joints within slab in locations as identified upon original Building Consent drawings.

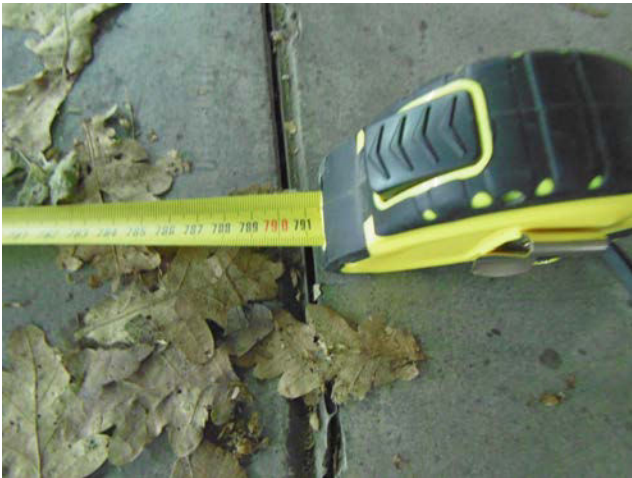
Photo 29

- 2.01.12 It was noted that the saw cuts where provided were in excess of the maximum 6 metre distance recommended between control joints within concrete slabs (refer to Photo 29) and did not continue for the width of the slab on either side of the columns in areas (refer to Photo 30). This has therefore led to further

cracking forming in the slab where movement has continued on the opposing side of the columns.

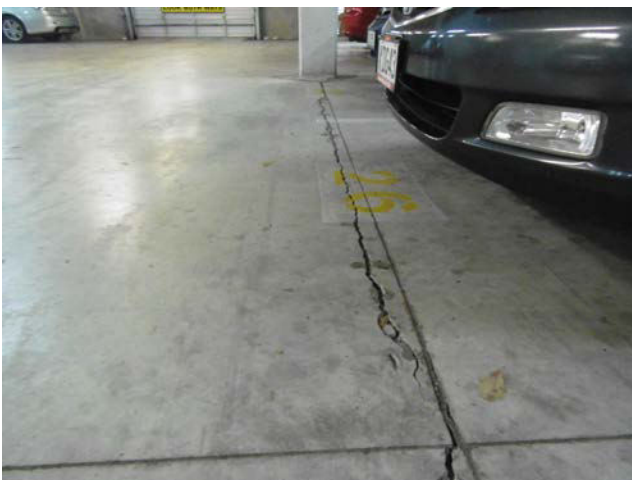
Photo 31

2.01.13 The worst section of cracking evident to the floor within the Basement was along Grid Line K, where the cracking was found to be up to 35mm wide and 60mm deep (refer to Photos 31 – 34). These cracks were reported upon within the ISPS Consulting Engineers Report dated 14 April 2016 (see attached Copy at Appendix F) as being up to 10mm in width and they recommended that if more significant cracks were identified then further investigation would be required as their recommended remedial methods may not be adequate enough. It is therefore recommended that the Engineers be invited to re-assess that crack and recommend further repairs.

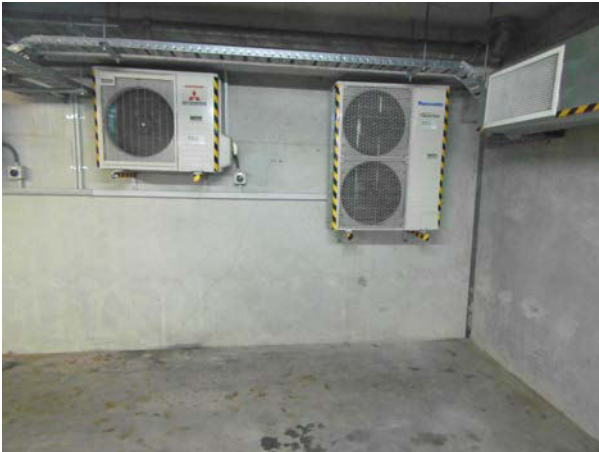
Photo 35

2.01.14 Cracking to the walls was also evident at Grid Line E, with diagonal cracks to the wall and floor in this area (refer to Photos 35 – 38). These again appear to have been inspected by ISPS Consulting Engineers and commented upon within their Report, with a proposed remedial solution outlined to attend to these and other cracks within the Basement. It is recommended that these repair works are undertaken to repair the cracking experienced by the building at present.

2. Undertake recommended epoxy injection and routing out and sealing crack repairs to walls within the Basement Car Park area and on external pre-cast panels in accordance with the Engineer's recommendations within their Report dated 14 April 2016 adjusted as necessary following a review of their findings.

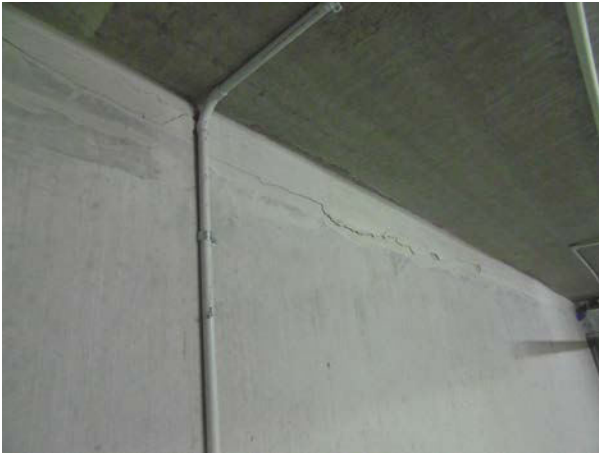
Photo 39

- 2.01.15 There was also however, evidence of what appear to be previous crack repairs at Grid Line E adjacent to the Car Park entrance (refer to Photos 39 and 40). The repair appears to have comprised the provision of a skim coat of plaster over the previous damage, but this is cracking, loose and falling away in areas.

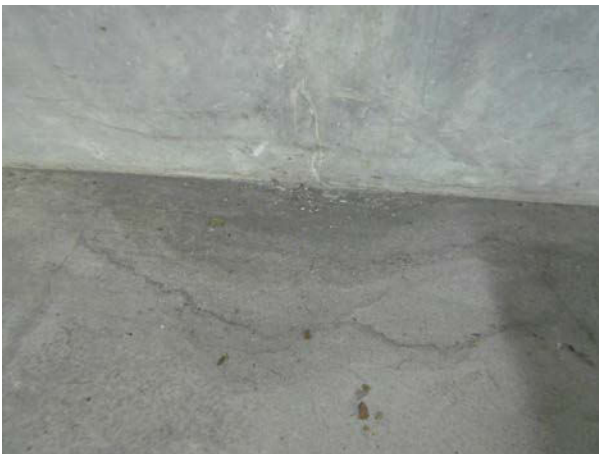
Photo 41

- 2.01.16 There is also some evidence of moisture entry into the Basement Car Park either through the waterproofing provided to the retaining section of the Car Park wall or at the junction of this with the floor slab to the ground level accommodation. This is visible where moisture stains are apparent at the base of the wall (refer to Photo 41) and where the cracks are evident upon the wall in various locations within the Car Park (refer to Photo 42).

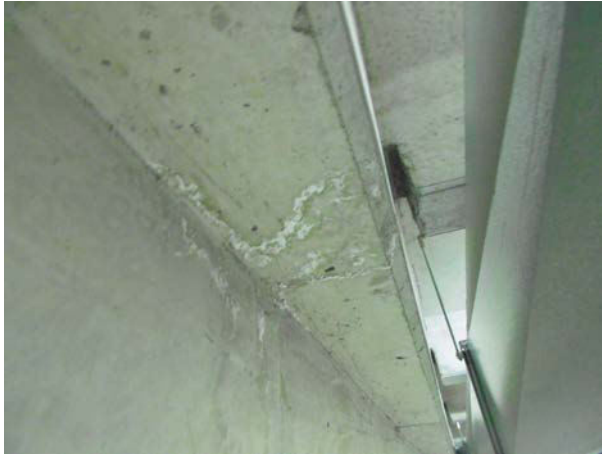
Photo 43

- 2.01.17 Staining to the underside of the beams supporting the ground level floor slab illustrate that the moisture may be entering behind the waterproofing at the junction of the floor slab with the retaining walls (refer to Photos 43 – 45). Visible drops of water were observed upon the beams at the time of our inspection (refer to Photo 46).

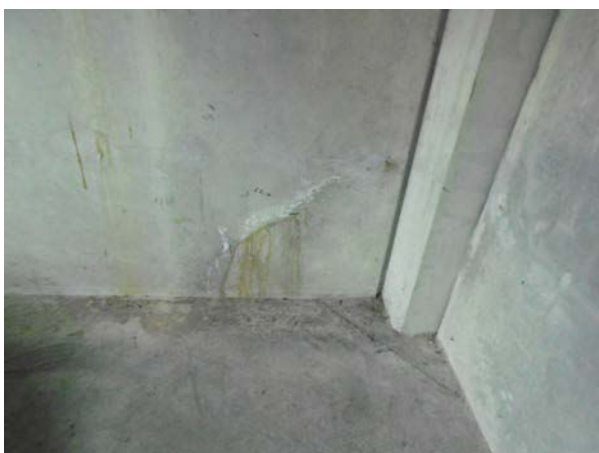
Photo 47

- 2.01.18 The evidence of moisture ingress was also noted at the north eastern end of the Car Park (refer to Photos 47 and 48), with cracking and quite distinct staining apparent at Grid Line M (refer to Photos 49 and 50). It is recommended that further investigation is undertaken to confirm the position in which moisture is entering to allow remedial works to be undertaken in order to prevent this becoming more significant.

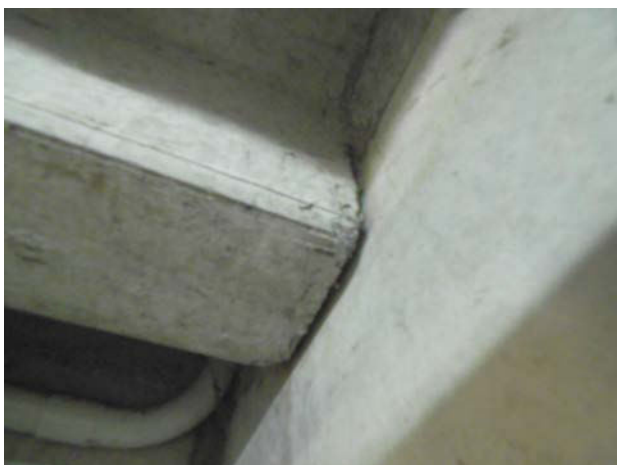
Photo 51

2.01.19 On the north western side of the Car Park it was also noted that the gaps between the beams and the wall differed in width (refer to Photos 51 and 52), which raises concern over the suitability if the bearing provided in this location.

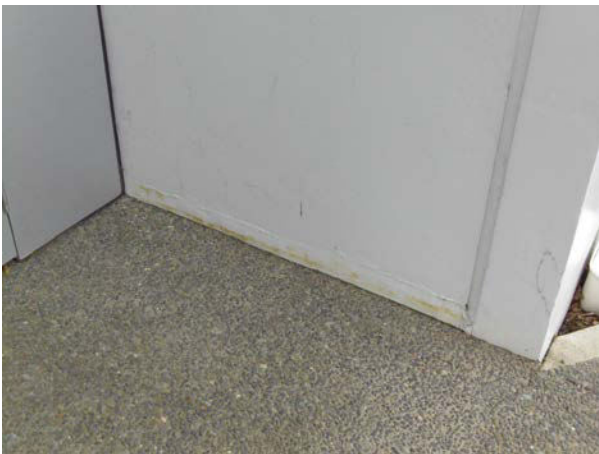
Photo 55

- 2.02.02 Where the paving provided adjacent to the entrance to the left of this section of the building is situated some corrosion staining is evident at the base of the pre-cast panels (refer to Photos 55 and 56). This suggests that moisture is holding in this location and may be seeping beneath the ground and possibly contributing to the moisture entry noted within the Basement from our internal inspection.

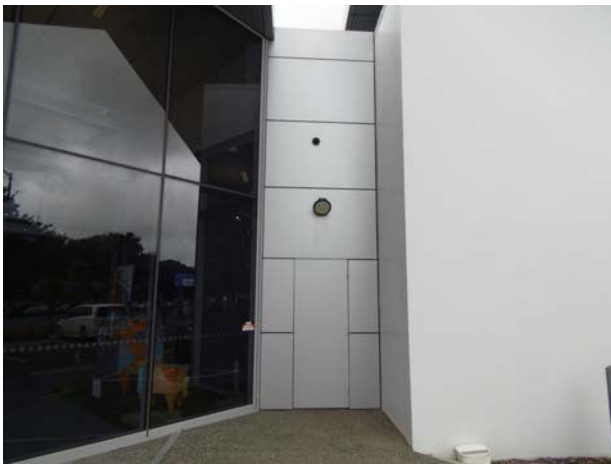
Photo 57

- 2.02.03 To the right and left sides of the main entrance aluminium composite panels have been installed as the cladding (refer to Photo 57). It was noted however, that this panelling continues to ground level, with no clearance between the cladding and adjacent ground, which may allow moisture to hold in that location and penetrate behind the cladding with no means of discharging away (refer to Photo 58). This is repeated on the left side, with only the sealant joint provided between the panel and adjacent paving provided to prevent moisture ingress (refer to Photos 59 and 60).

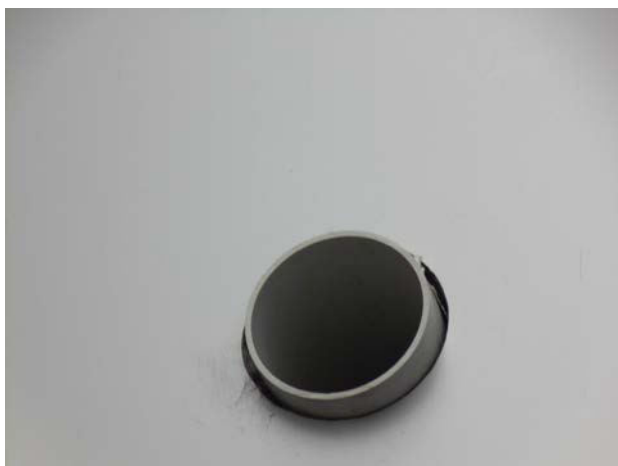
Photo 61

- 2.02.04 It was also noted that the overflow outlet to the right side of the entrance, which penetrates the composite panels has no seal around its perimeter to the right side (refer to Photo 61), whereas it does to the left side (refer to Photo 62). This will therefore allow moisture to penetrate behind the composite panel, with no method of drainage installed to this section of wall to allow any penetrating moisture to drain away.

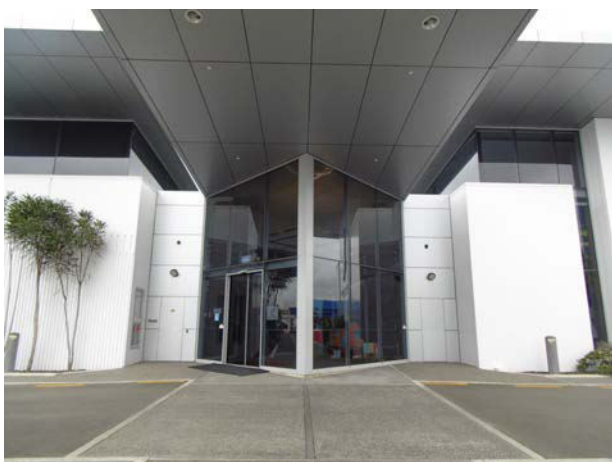
Photo 63

2.02.05 The aluminium composite panels used as a soffit system above the main entrance are also provided with no drainage slots (refer to Photos 63 and 64). Elsewhere around the perimeter of the building drainage slots have however been installed as is recommended on comparable systems (refer to Photos 65 and 66)

8. Attend to areas of corrosion evident to fire exit gate and fencing to Terrace.
9. Retro-fit pressure equalisation and drainage slots within underside of Aluminium Composite Panels provided to soffit of building where missing.

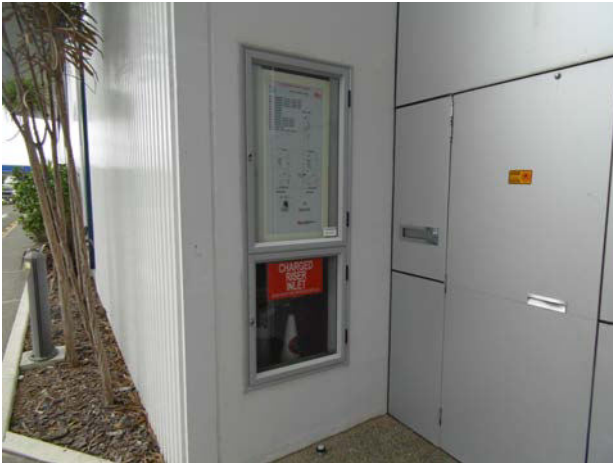
Photo 67

- 2.02.06 Where the riser inlet and alarm is housed within the pre-cast panel to the left side of the entrance no flashings have been installed to the perimeter of the housing to prevent moisture entry in that location (refer to Photos 67 and 68). It is recommended that this is either provided with perimeter flashings or sealed around its perimeter to prevent moisture entering behind the panel in the future.

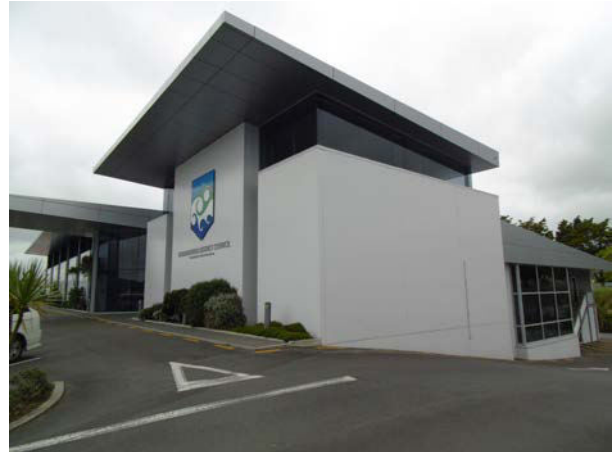
Photo 70

- 2.02.07 The gardens to the front of the north west facing elevation abut the pre-cast panels that form its construction (refer to Photos 69 and 70) and it is understood that the retaining section of this wall that forms the front wall of the Basement Car Park has been provided with a tanking system to prevent moisture ingress. A detailed inspection of the tanking system was not able to be undertaken without removing sections of the garden to confirm how this is applied at the top of the retaining section, but it is evident that moisture is penetrating and affecting the Basement Car Park from our internal inspection. It would be recommended therefore that some further investigation is undertaken to confirm how this has been detailed in order to prevent moisture entry at the junction with the floor slab where moisture appears to be penetrating from our internal inspection.

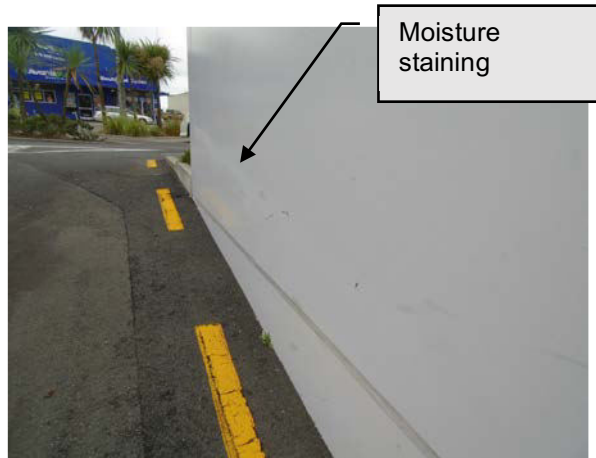
Photo 72

- 2.02.08 This is also a concern to the western end of the building where the road leading to the rear abuts the pre-cast panels (refer to Photo 71). In this position some moisture staining was noted to the panels at low level, which suggests that moisture is present behind the paint finish applied (refer to Photo 72) and this may therefore be penetrating behind the waterproofing and affecting the Basement Car Park.

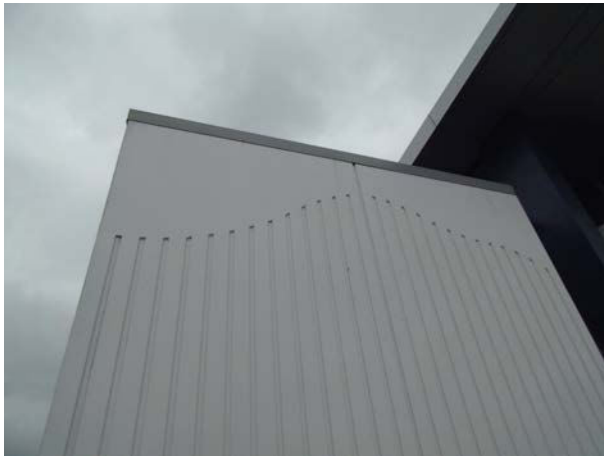
Photo 77

- 2.02.11 At the eastern end of the front elevation and on the north east elevation staining is evident to the pre-cast panels beneath the cap flashing. These stains are evident at the joints between the flashing and at fixing points where moisture has been concentrated and created the stains (refer to photos 77 – 79). It should be ensured that the seal between the joints is maintained effectively to prevent moisture entry beneath the capping.

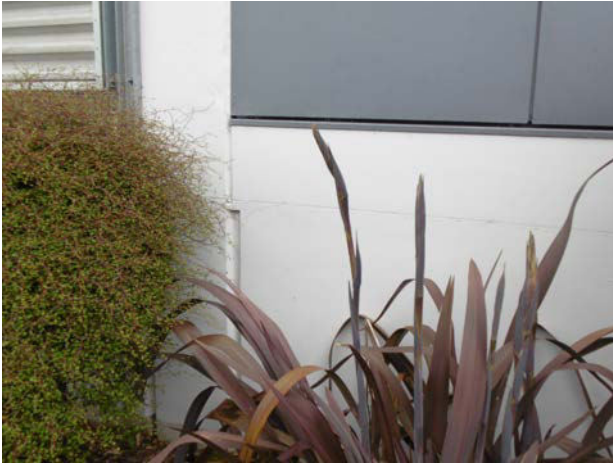
Photo 80

- 2.02.12 On the north east elevation some fracturing of the pre-cast panels was noted at low level (refer to Photos 80 and 81). Whereas more severe fracturing was evident on the opposing side of the building on the south west elevation where cracking is evident at the junction of the pre-cast panels to the side of the Council Chamber which may be related to movement during recent earthquakes (refer to Photos 82 – 85). These cracks have also allowed moisture to enter behind the paint coating provided to the pre-cast panels and this is causing the coating to bubble and flake away.

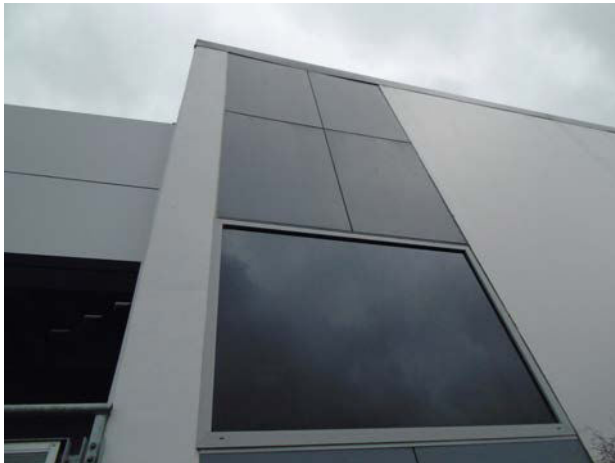
Photo 86

2.02.13 Further cracking of the sealant at the jambs of the joinery was noted to the windows within the fibre-cement façade panel clad section of the north east elevation (refer to Photos 86 and 87). These need to be regularly maintained in order to prevent moisture entry in these locations.

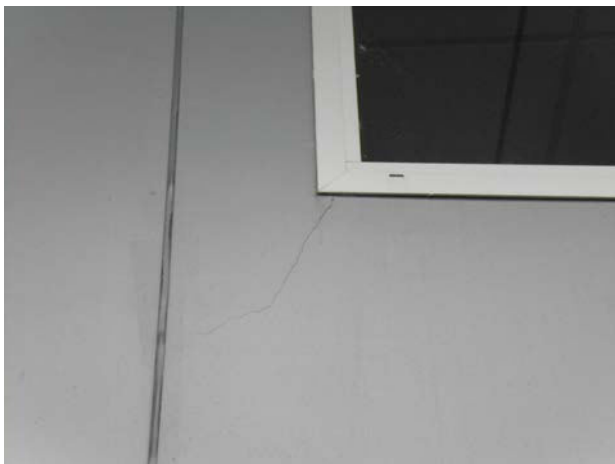
Photo 88

- 2.02.14 Where the joinery is installed directly within the façade panel cladding cracking of the fibre-cement sheets was noted adjacent to them on both the north east and south east elevations (refer to Photos 88 – 89) and these will require repair to prevent moisture entering and causing the sheets to delaminate.

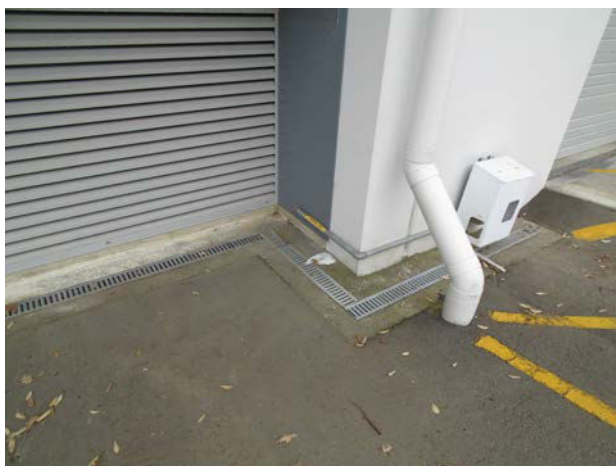
Photo 90

- 2.02.15 Along the south east facing elevation it was noted that the location through which the gas supply pipe enters the cladding to the Basement Car Park is open and not protected against moisture or vermin entry (refer to Photos 90 and 91). It is recommended that this penetration is sealed with a protective flange.

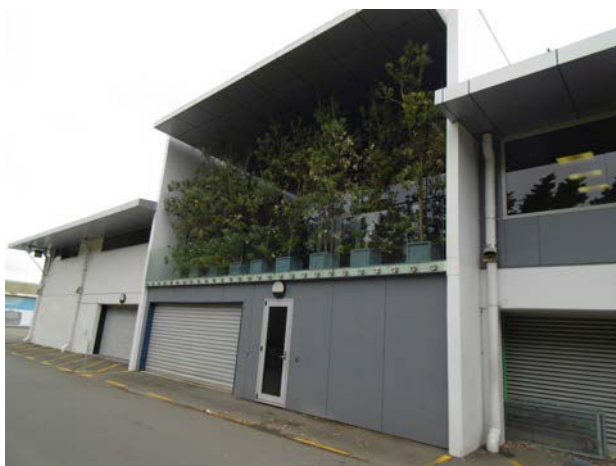
Photo 92

2.02.16 At the eastern end of the south east facing elevation a deck is provided at the rear of the Entrance Lobby to the building (refer to Photo 92). This is provided with a membrane to its surface over which ceramic tiles have been installed. Unfortunately, the membrane does not appear to have been applied to form an upstand to the side at the junction with the pre-cast panels at either end and moisture entry into the panels in these locations has caused some cracking to form at ether end of the deck (refer to Photos 93 and 94).

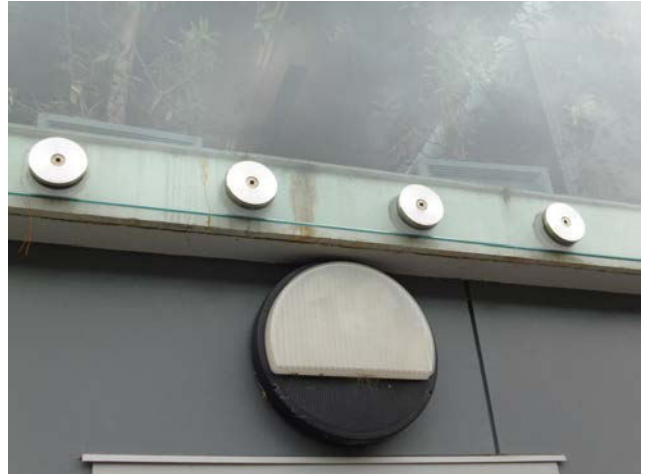
Photo 95

2.02.17 Damage has occurred to the underside of the slab forming the deck where no drip detail is installed and the lack of a drip detail to the underside of the tiles provided at the edge of the deck is allowing moisture to stain the edge of the slab (refer to Photo 95). It is recommended that the detailing to this deck be amended to prevent further moisture damage occurring.

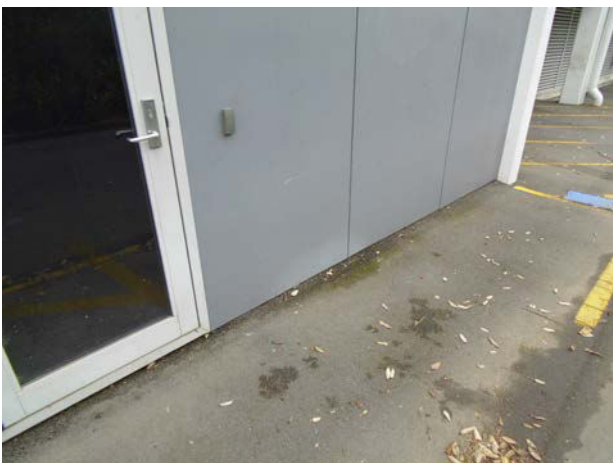
Photo 96

2.02.18 Beneath the rear deck the fibre-cement façade panel cladding installed continues to ground level where it abuts the adjacent drive and is not provided with the minimum recommended gap of 100mm between the base of the cladding and adjacent ground (refer to Photos 96 and 97). This will allow moisture to affect the fibre-cement sheet and also prevent drainage from the cavity provided to the rear of the fibre-cement sheet and should be amended.

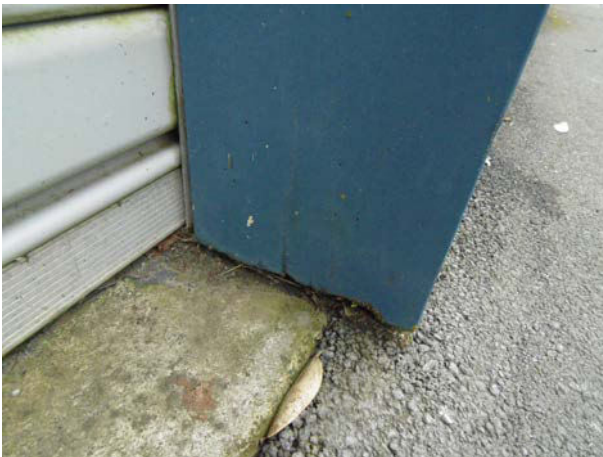
Photo 98

2.02.19 To the side of the façade panel cladding the reveal to the entrance to the Basement Courier Delivery Area also abuts the adjacent ground and is deteriorating (refer to Photo 98). It is recommended that the base of the reveal

is removed to provide some clearance between the reveal and adjacent ground surface.

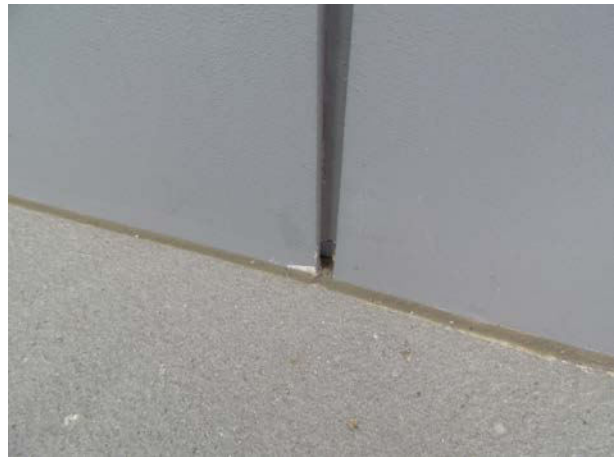
Photo 101

- 2.02.20 A further lack of clearance between the base of the façade panel cladding and the adjacent ground was noted where this cladding is used on the Terrace Mezzanine level (refer to Photos 99 – 101). The junction between the cladding and the adjacent tiles in that location is sealed with a sealant, which prevents any moisture that has penetrated behind the cladding from escaping.

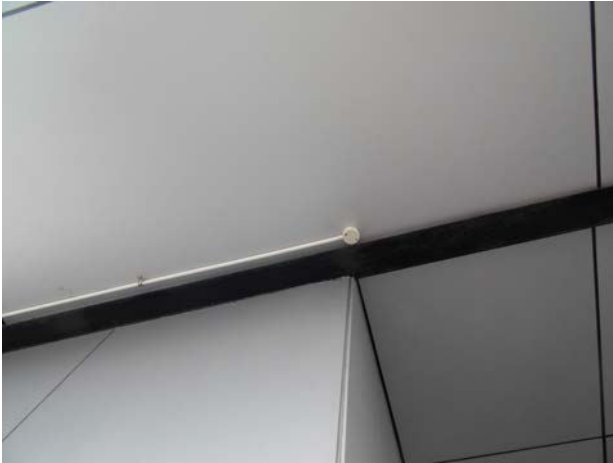
Photo 102

- 2.02.21 On the terrace at Mezzanine level, it was also noted that the coatings to the steel frame at roof level were deteriorating and require attention (refer to Photos 102 and 103).

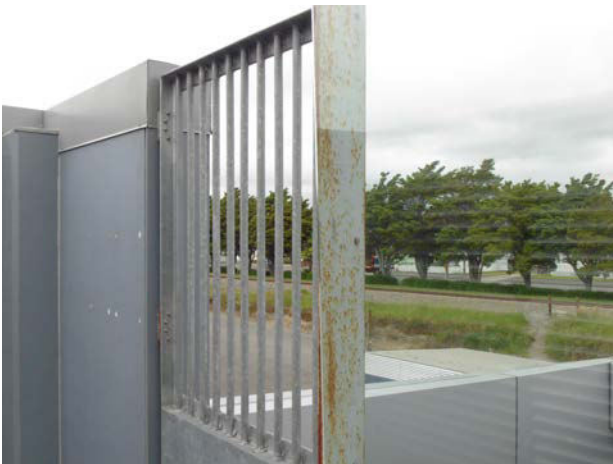
Photo 104

2.02.22 Additional corrosion was also noted to the gate to the Fire Exit leading from the Terrace at Mezzanine level (refer to Photos 104 and 105).

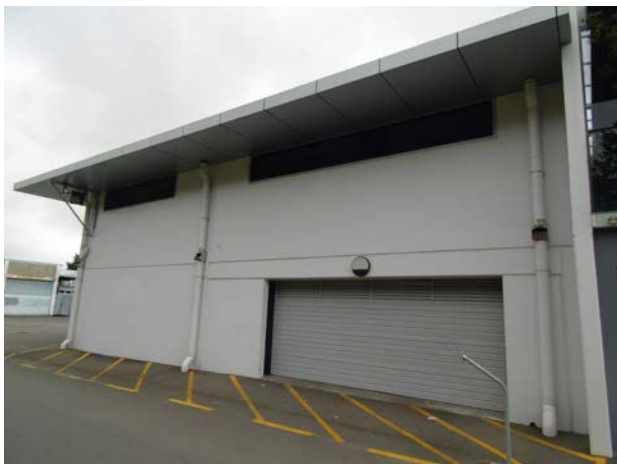
Photo 106

2.02.23 Deterioration of the coatings provided to the pre-cast panels was noted in a number of areas around the perimeter of the building where moisture had entered behind the coats. This was evident at high level and particularly adjacent to cracks where they have formed on the south west elevation, but also on the panels to the south east elevation (refer to Photos 106 – 108). It is considered therefore that the exterior of the building is due for the coating system provided to the pre-cast panels to be renewed.

17. Re-coat all external cladding with a minimum of two coats of an acrylic paint system to maintain the weathertightness of the cladding following all necessary repairs having been completed.

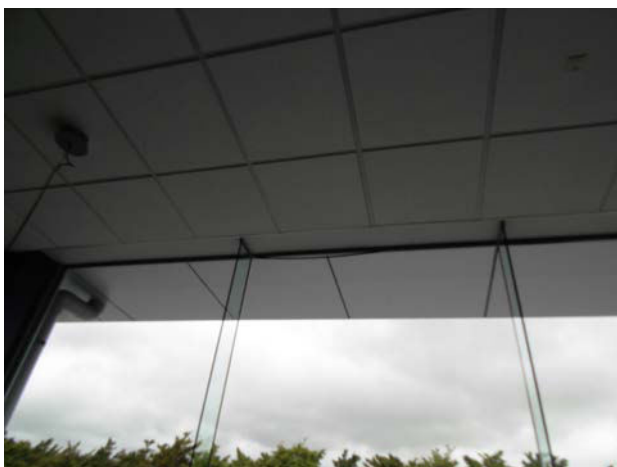
Photo 109

2.02.24 Our inspection also revealed that the glazing rubbers to a number of the windows to the Mezzanine level were loose and that these need to be reinstated or replaced where they have shrunk (refer to Photos 109 and 110).

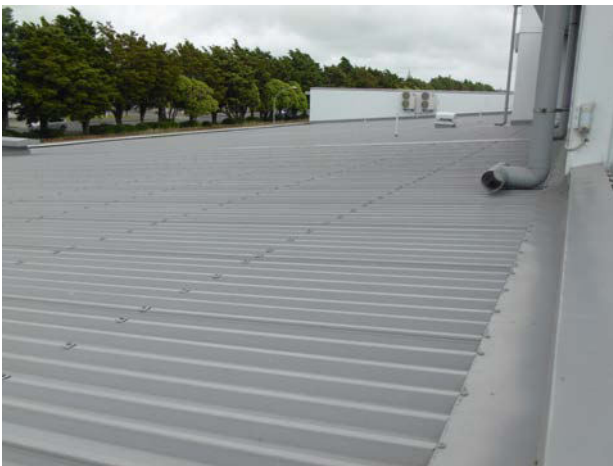
Photo 111

2.02.25 During our inspection we were unable to inspect the condition of the roof above the Mezzanine level or the Public Entrance Foyer due to lack of access and our inspection of the roof above the ground level accommodation was restricted to what could be seen from the Terrace and the Mezzanine level (refer to Photos 111 and 112). It is apparent that leaks through the internal gutter to the ground level roof have affected the interior at Office 136 and further investigation in respect of the repairs required in that position and also to prevent moisture entry affecting the Public Entrance Foyer would be recommended.
