Design Review and Post-Earthquake Assessment

Horowhenua District Council Building

126-148 Oxford St, Levin

Reference: 2788-8773

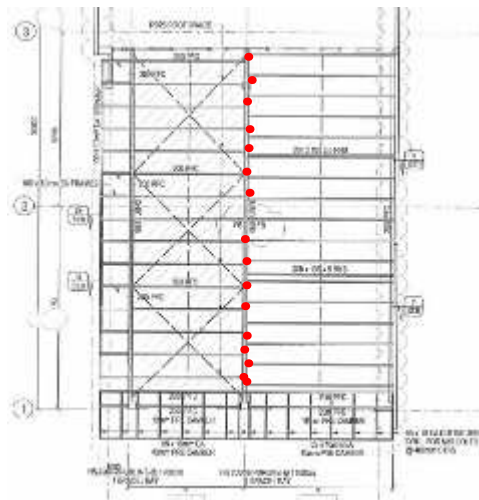
Figure 1 Part Plan of roof bracing over Civil Defence headquarters offices

10.01 Roof Bracing Civil Defence offices (Grids A-D and 1-3):

The Tensile Capacity of rod bracing and flexural stiffness of rafters forming the rod bracing above the Civil Defence Offices. These components were assessed to have a score of ~60% of IL2 and <30% of IL4 (Grids A-D). Loads to these elements include the mass of the wall on Grid D. Similar issues apply to the rod bracing over the other offices on Lines 1-3 Grid E-F from the face loaded wall on Grid E)

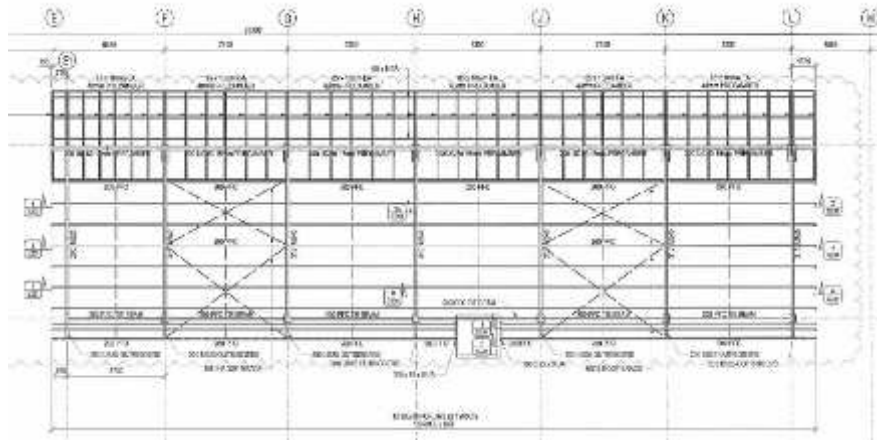
Figure 3 Partial Roof Plan Over offices lunchroom

10.03 Roof Bracing over office Lunchroom (Grids E-N and 3-4)

The Tensile Capacity of the rod Bracing and point loads to the rafter causing minor axis flexure to rafters over the office space causing large lateral movement and potential buckling

of the rafter to these areas.

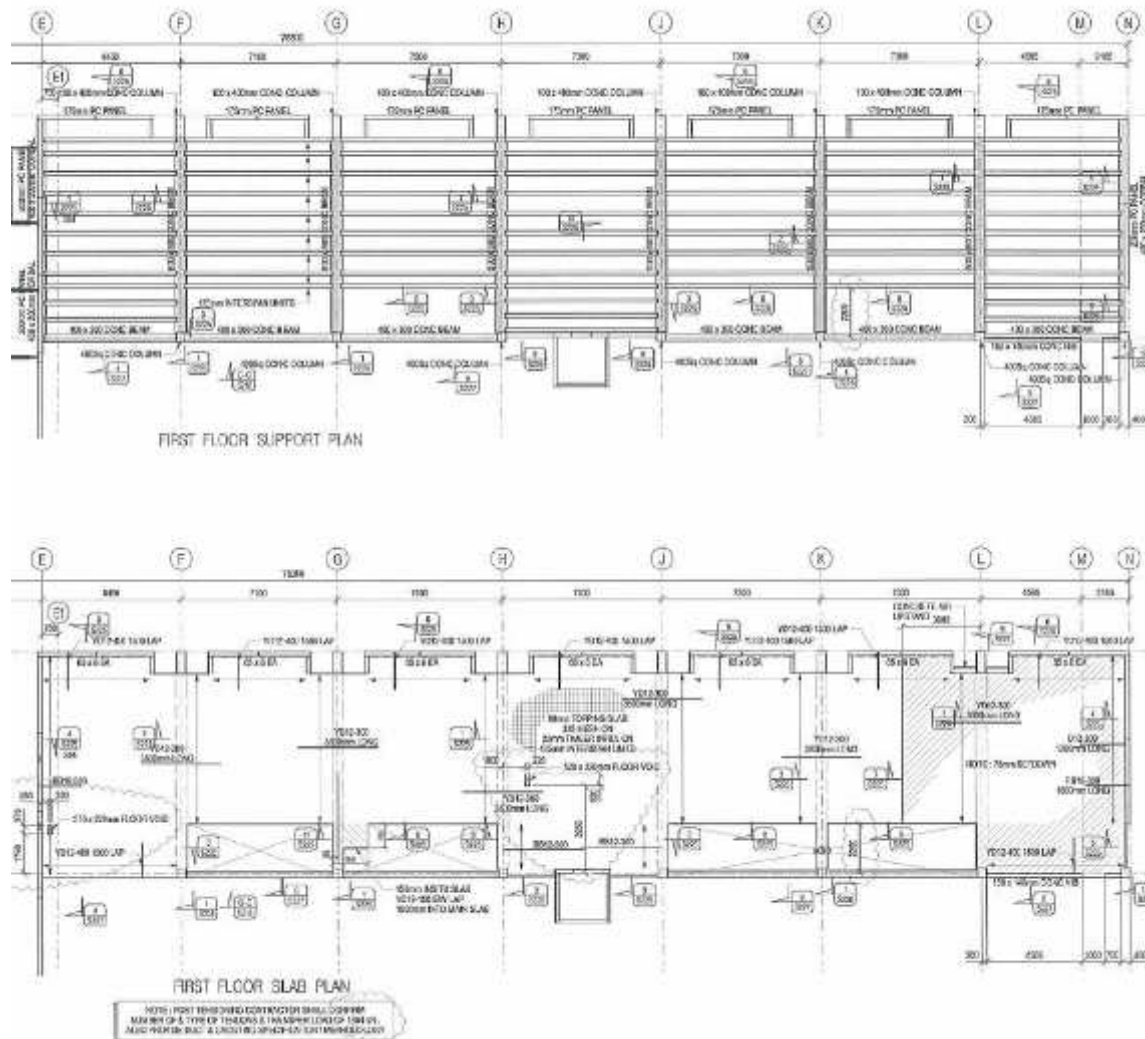
Figure 4 Floor Slab for mezzanine offices.

10.04 Floor Diaphragm to offices level 1 (Grids E-N and 3-4)

The diaphragm for the level 2 offices and lunchroom if lateral support only provided by end walls for horizontal span in flexure have been assessed as ~34% at IL2 or 28% at IL4

If frame action of intermediate frames (Grids E-N) is considered, then this area able to carry lateral loads as fixed base columns in flexure the above system then has an assessed rating of 50% at IL2 and <30% at IL4.

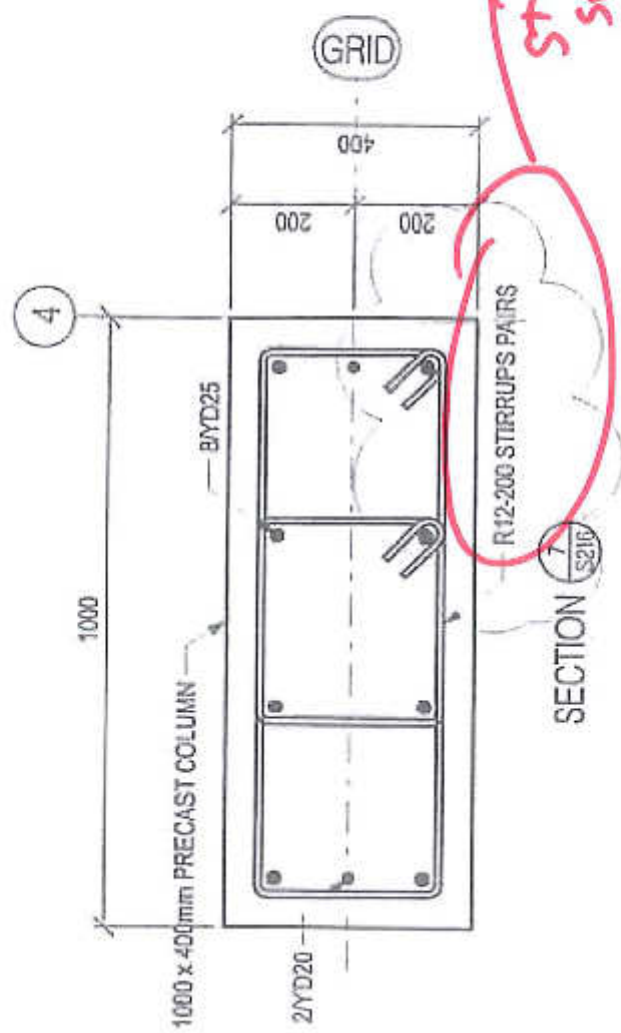
This column has stirrups spaced closer than other columns however they are still further than $d/3$ apart plus they are hairpins and not closed. For these stirrups to be compliant they would need to be welded where the hairpins lap otherwise they will not provide any confinement as the column concrete cover degrades. There is no note requiring this to occur on the drawings or specification hence this would need to be investigated. Furthermore the detailing between the steel truss chords and concrete column has eccentricities that cause secondary effects that can be difficult to quantify plus there is a lack of detail of how the column interacts with basement level and continuity that ensures the column can achieve full capacity.

Stirrup spacing

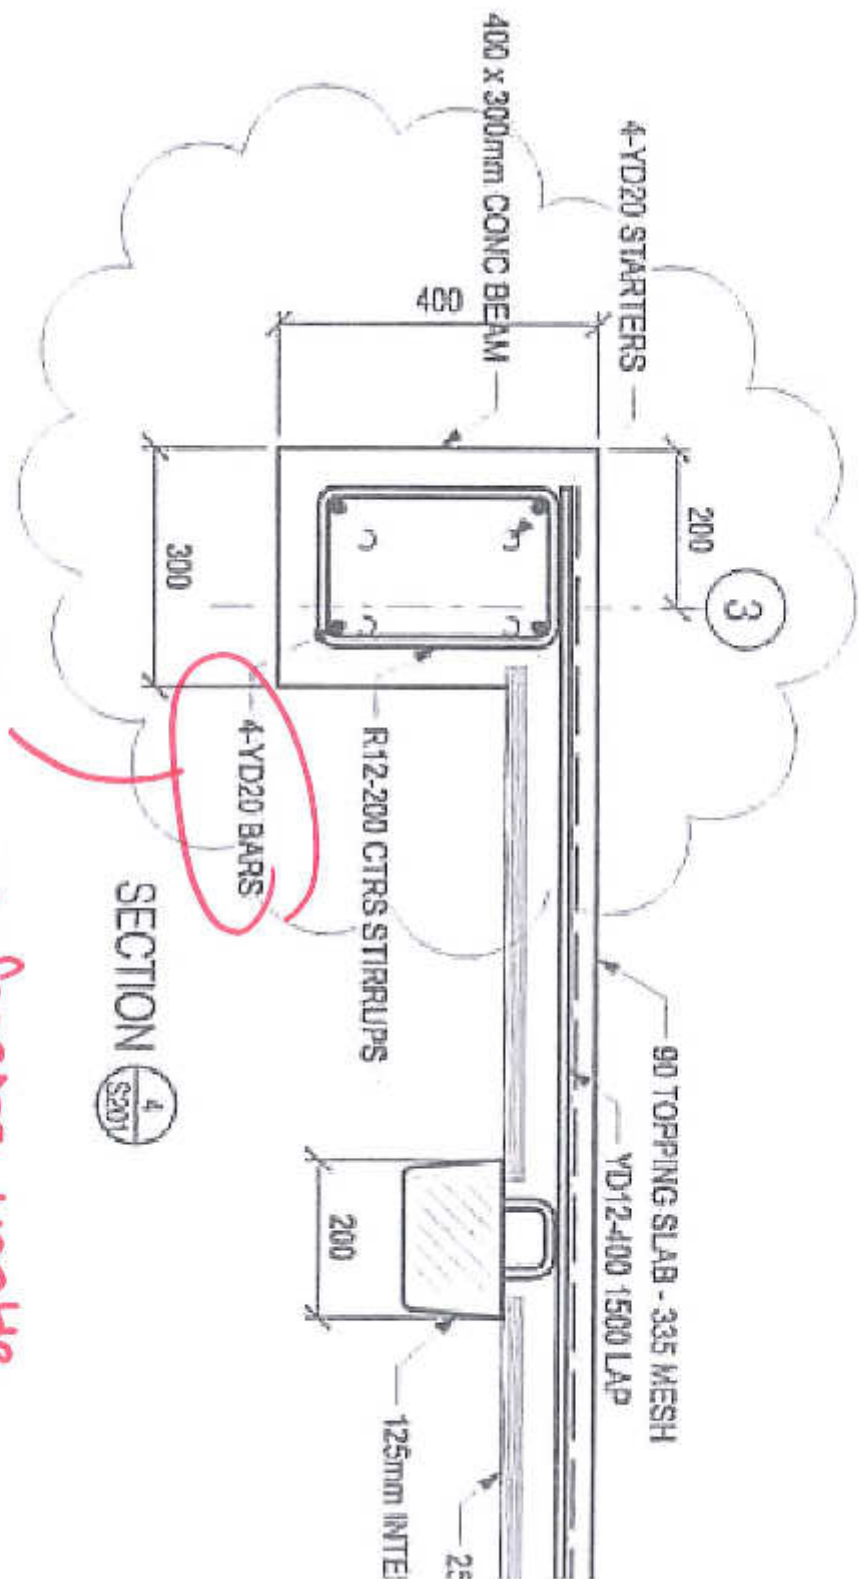
Diagram 15

Beam reinforcing unable
to take tension forces
in diaphragm

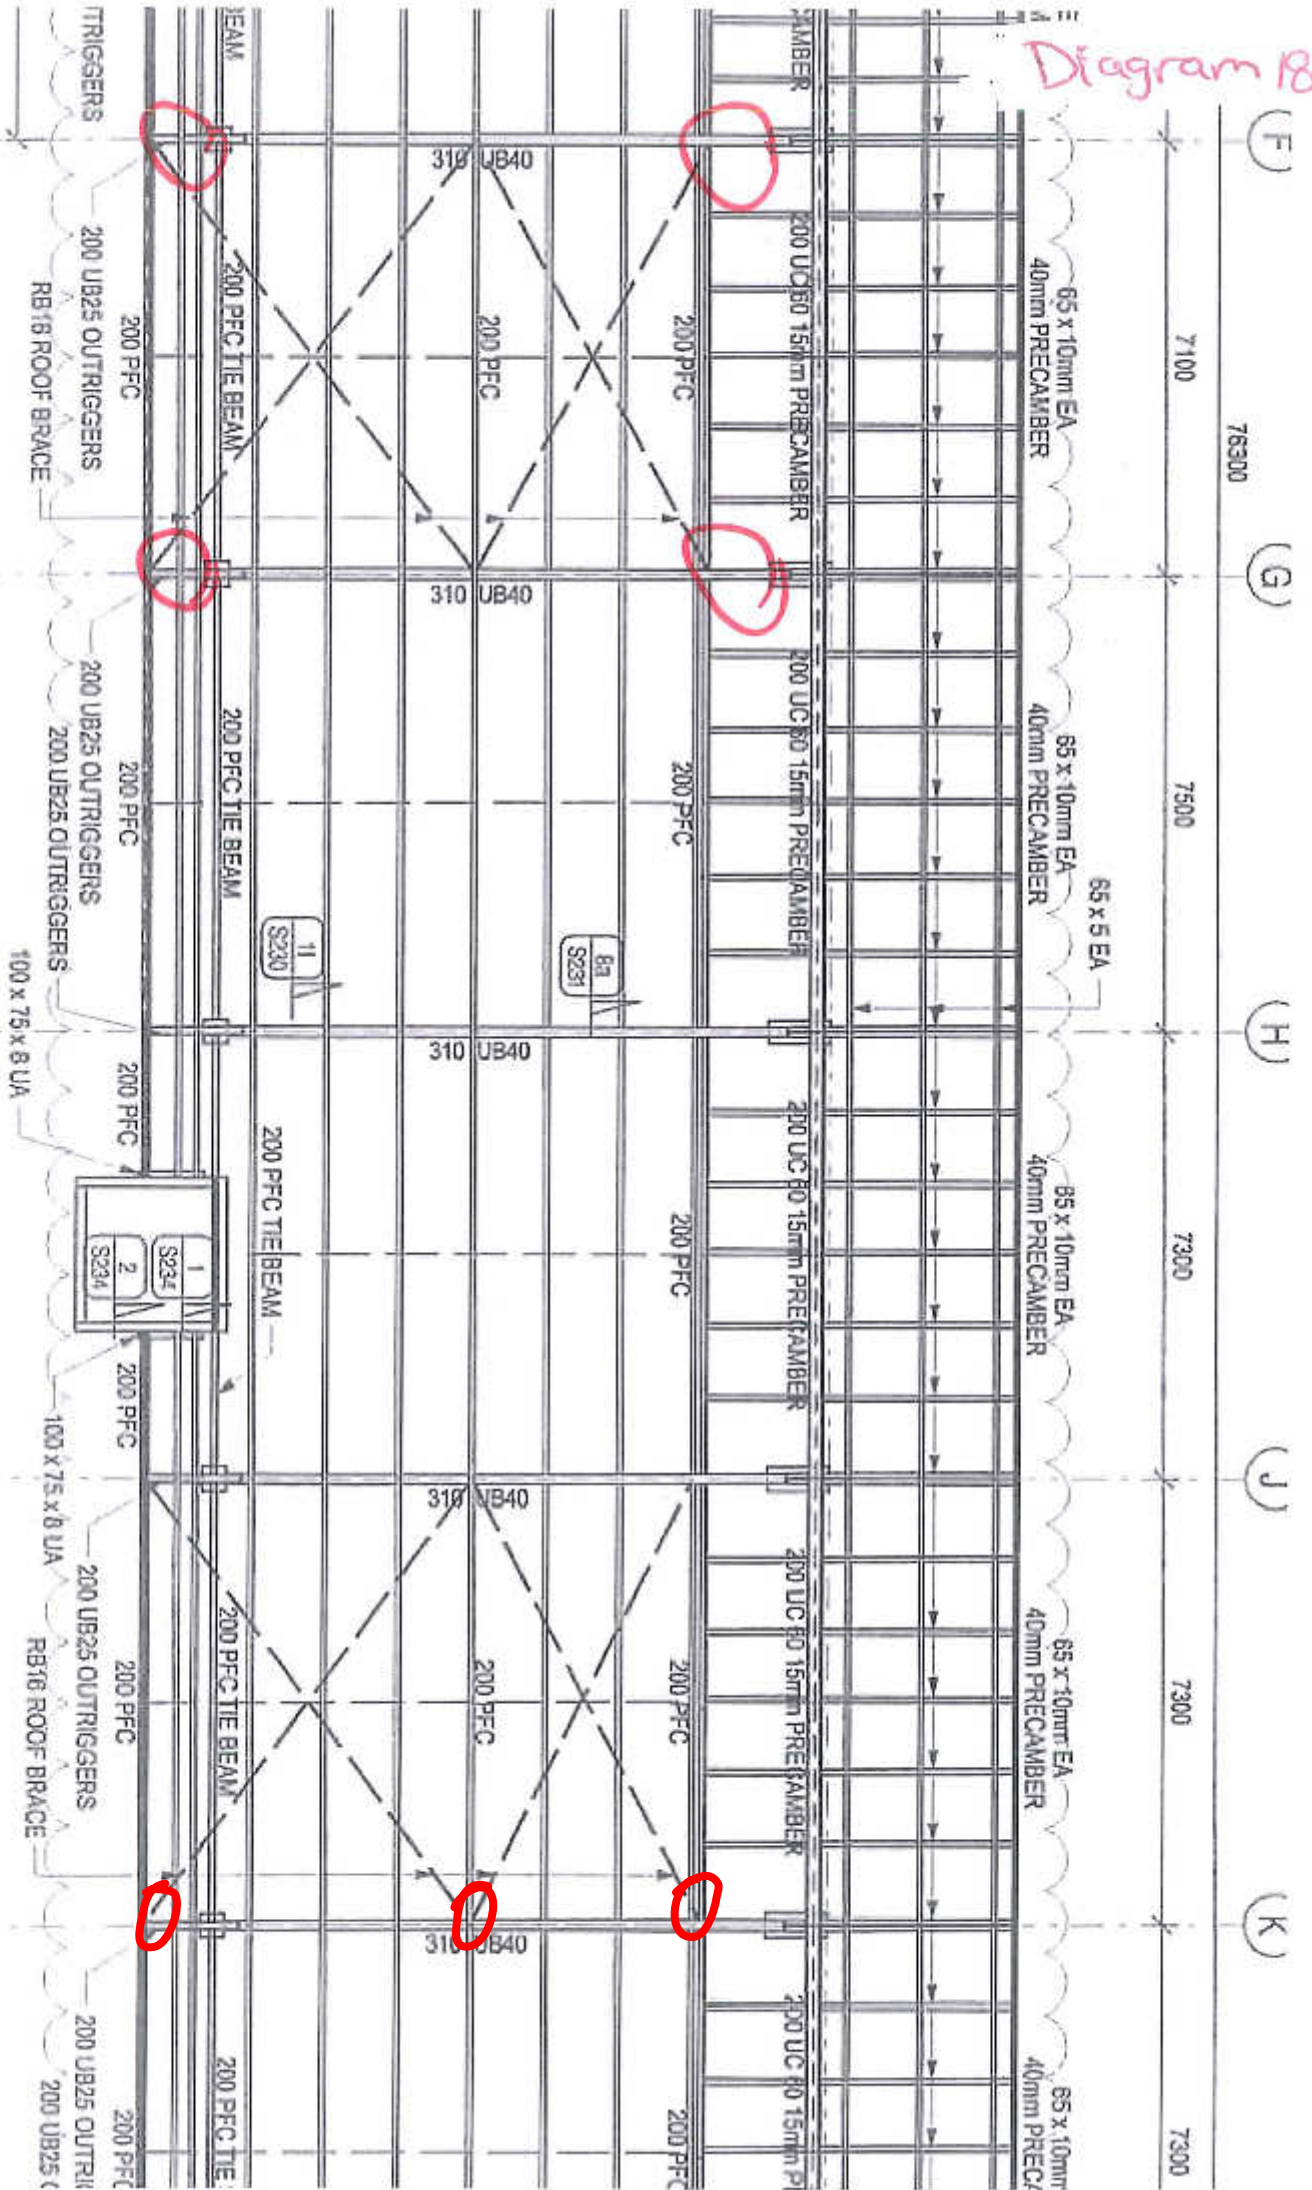
Diagram 18

The bracing at the high level between grids E and L have design issues due to the bracing being terminated away from the vertical brace element on the rafter. This will cause secondary stresses on the beams in their weak direction and becomes the governing strength of the system which has strengths less than that required by the compliance documents at the time. (See Appendix A, Diagram 18)

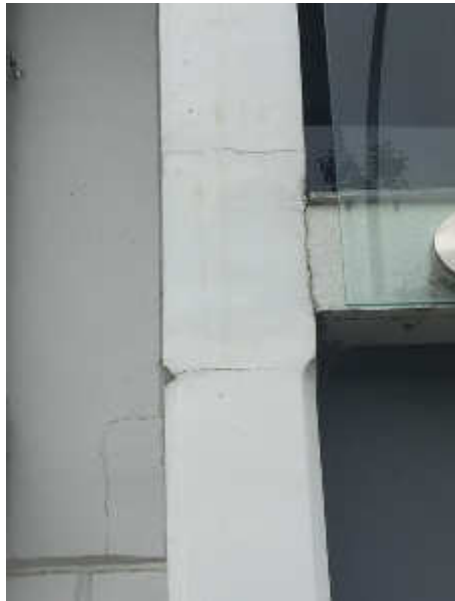
Movement in cold joints have been noted in the shear wall elements at the interface between upper panels, floor and lower panels. These need to be monitored to ensure movement does not propagate or become worse. It is likely these cracks are due to a combination of minor movement due to lateral loads, shrinkage of concrete away from the cold joint and the presence of the cold joint.

Figure 4 Cold Joint movement Cracks on Grid 1

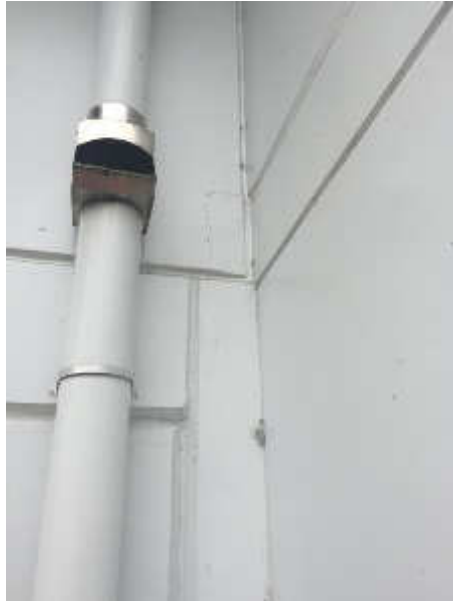
Figure 5 Beam joint movement at intersection Grid B and Grid 2

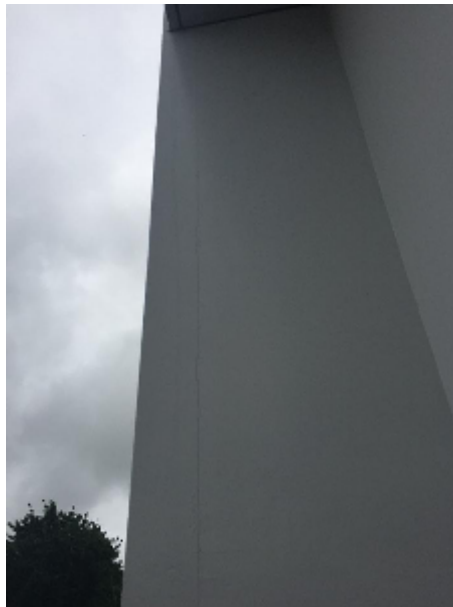
Figure 6 Movement in Joint between panel and Column at intersection of Grid A and Grid 3

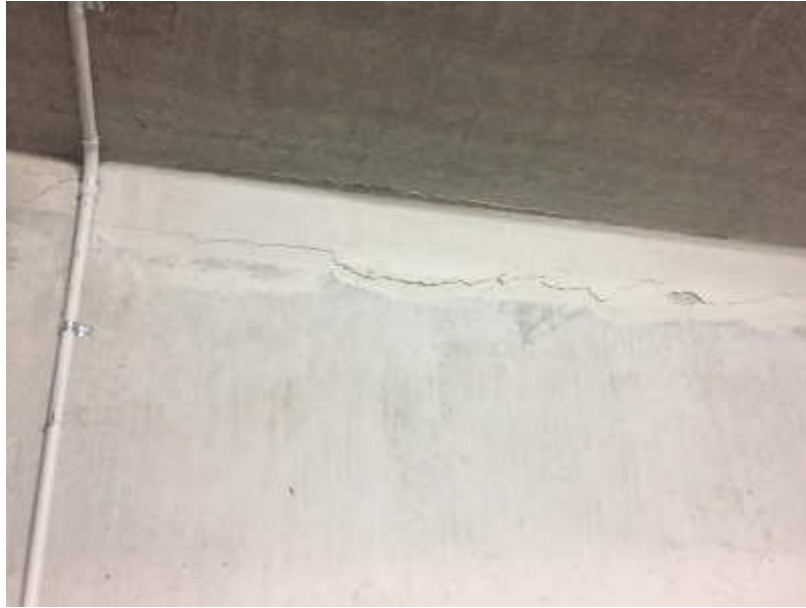
10. Minor non structural cracks to panel in basement
Minor cracks to panel base/corner to rear a south wall not affecting strength.
No action required

Figure 7 Floor Wall intersection in basement typical movement defect.
