# **CONDITION REPORT**

## **FOR HOROWHENUA DISTRICT COUNCIL CIVIC BUILDING**

**AT  
126 – 148 OXFORD STREET  
LEVIN, 5510**

**REPORT NO. BC068**

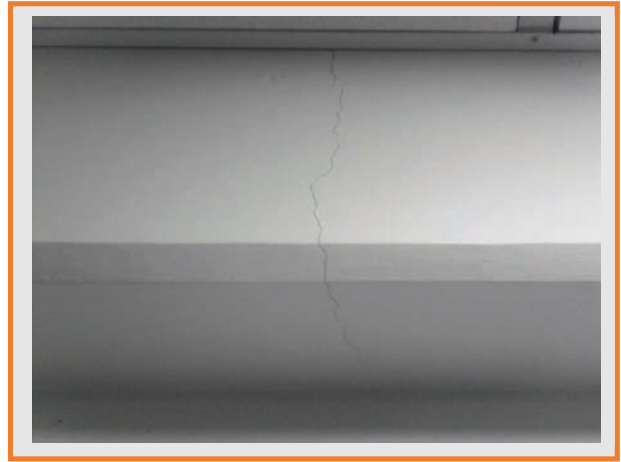
Photo 8

- 2.01.05 At ground level within the Offices some additional cracking was noted. Within Office 146 a crack was noted to the beam on the south-west side of the building approximately 1.7m from the fire exit door (refer to Photos 7 and 8), with additional cracking noted along the same elevation wall beneath the window opening in Office 148 (refer to Photo 9). Some cracking and loose plaster was also noted at the junction of the internal partition to Office 147 with the steel frame (refer to Photo 10). Again these are not considered to be significant, but are signs of general movement that has occurred to the building since its construction and will require repair and monitoring for further deterioration.

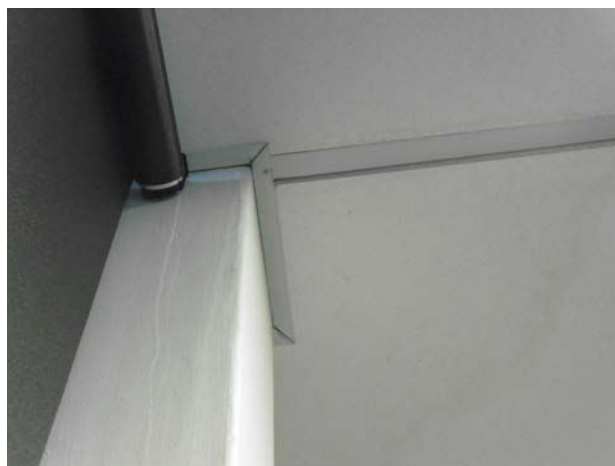
Photo 12

2.01.06 Within Office 146 some staining was also evident to the ceiling adjacent to the north west elevation and beneath the terrace area on the Mezzanine level above (refer to Photo 11). An inspection of the column adjacent to the window in this location revealed drip runs from the ceiling level down the column (refer to Photo 12) and staining and cracking of the column at the base (refer to Photo 13). This was repeated on the opposing side of the window (refer to Photos 14 and 15) and confirms therefore that moisture has penetrated from above, it is suspected through the junction of the terrace waterproofing with the structural elements above this area. It is recommended therefore that further investigation is undertaken regarding the cause of this leak to ensure that it is rectified effectively.

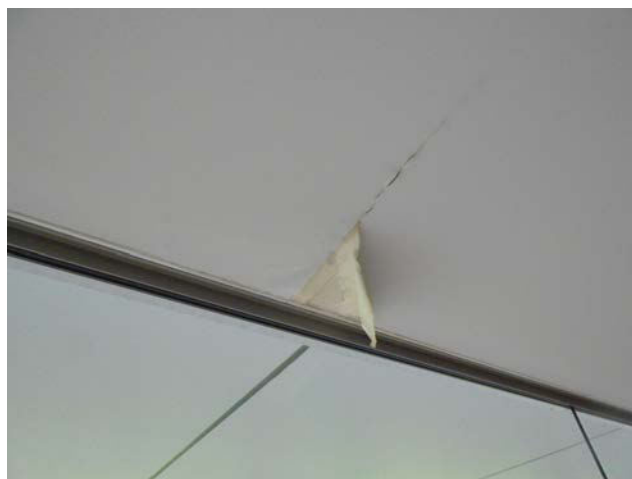
Photo 17

- 2.01.07 Within Office 136 there was evidence of moisture entry where cracking and deterioration was noted to the ceiling and the custom wood shelving has warped (refer to Photos 16 – 18). This moisture entry appears to be due to a leak from the internal gutter provided almost directly above this area and further investigation in respect of the cause and remedial works necessary should be undertaken to resolve it.

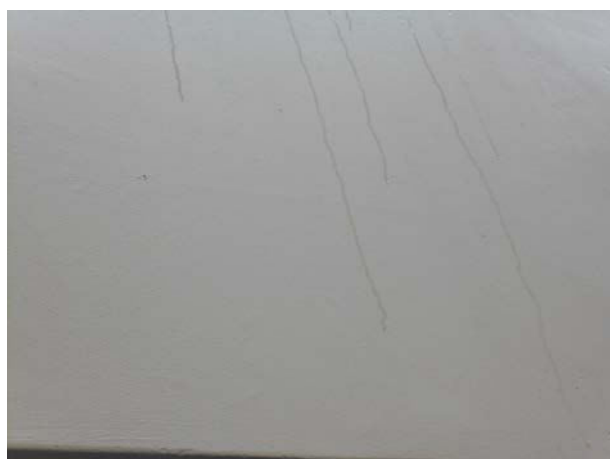
Photo 20

2.01.08 Further signs of moisture and cracking to the walls was noted within the Public Entrance Foyer. Above the entrance to Area 116 some moisture runs were noted to the wall at the time of our inspection either due to moisture entry or condensate forming on the underside of the glazing to the roof above this area (refer to Photos 19 and 20). Some cracking was also noted adjacent to the opening (refer to Photo 21).

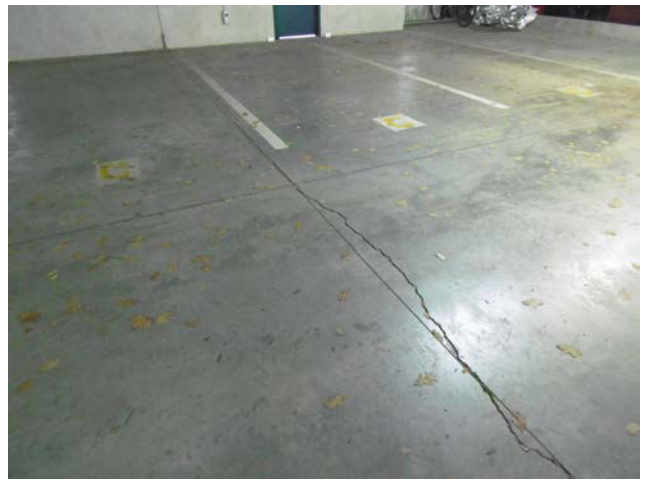
Photo 26

- 2.01.11 Cracking was evident adjacent to the saw cuts provided to the concrete slab forming the Car Park floor as control joints to control the amount of cracking that occurs (refer to Photos 25 – 27). These cracks have formed where they are expected at or adjacent to the weak points formed by the saw cuts. However, it was noted that the frequency of the saw cuts was not as per the design drawings, which showed them running perpendicular to all columns and to the centre of the entrance opening area at the south western end (refer to Photo 28). This lack of saw cuts may have increased the amount of cracking that has occurred in those areas.

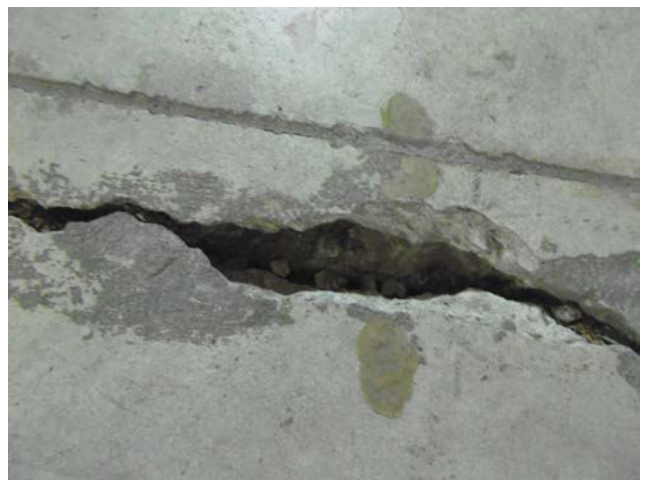
Photo 32

2.01.13 The worst section of cracking evident to the floor within the Basement was along Grid Line K, where the cracking was found to be up to 35mm wide and 60mm deep (refer to Photos 31 – 34). These cracks were reported upon within the ISPS Consulting Engineers Report dated 14 April 2016 (see attached Copy at Appendix F) as being up to 10mm in width and they recommended that if more significant cracks were identified then further investigation would be required as their recommended remedial methods may not be adequate enough. It is therefore recommended that the Engineers be invited to re-assess that crack and recommend further repairs.

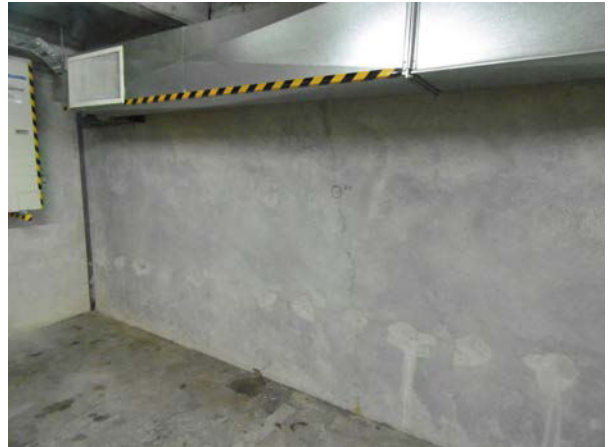
Photo 36

2.01.14 Cracking to the walls was also evident at Grid Line E, with diagonal cracks to the wall and floor in this area (refer to Photos 35 – 38). These again appear to have been inspected by ISPS Consulting Engineers and commented upon within their Report, with a proposed remedial solution outlined to attend to these and other cracks within the Basement. It is recommended that these repair works are undertaken to repair the cracking experienced by the building at present.

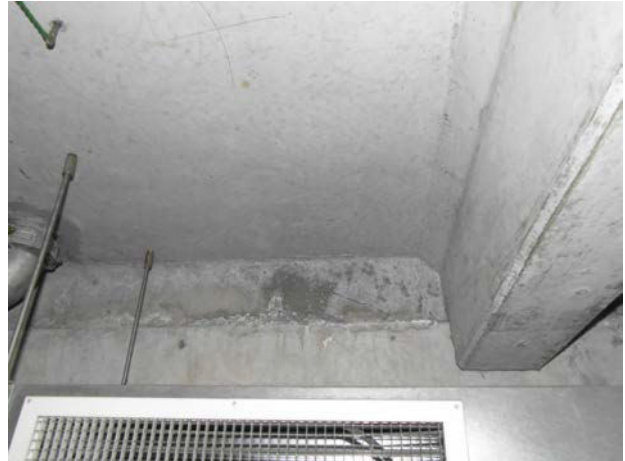
Photo 44

- 2.01.17 Staining to the underside of the beams supporting the ground level floor slab illustrate that the moisture may be entering behind the waterproofing at the junction of the floor slab with the retaining walls (refer to Photos 43 – 45). Visible drops of water were observed upon the beams at the time of our inspection (refer to Photo 46).

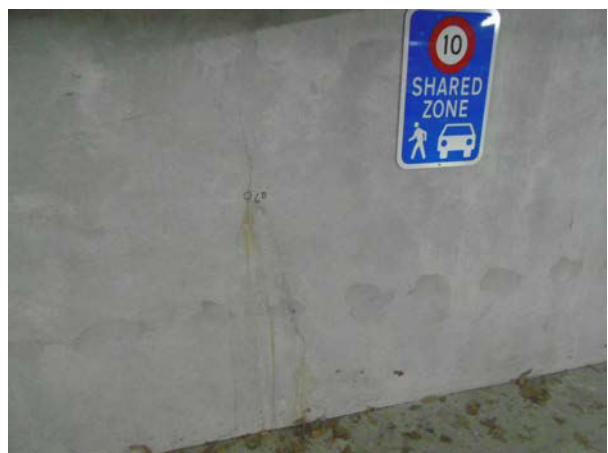
Photo 48

- 2.01.18 The evidence of moisture ingress was also noted at the north eastern end of the Car Park (refer to Photos 47 and 48), with cracking and quite distinct staining apparent at Grid Line M (refer to Photos 49 and 50). It is recommended that further investigation is undertaken to confirm the position in which moisture is entering to allow remedial works to be undertaken in order to prevent this becoming more significant.

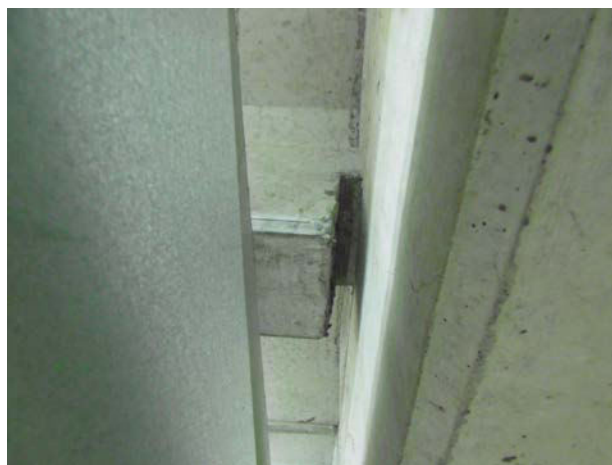
Photo 52

2.01.19 On the north western side of the Car Park it was also noted that the gaps between the beams and the wall differed in width (refer to Photos 51 and 52), which raises concern over the suitability if the bearing provided in this location.

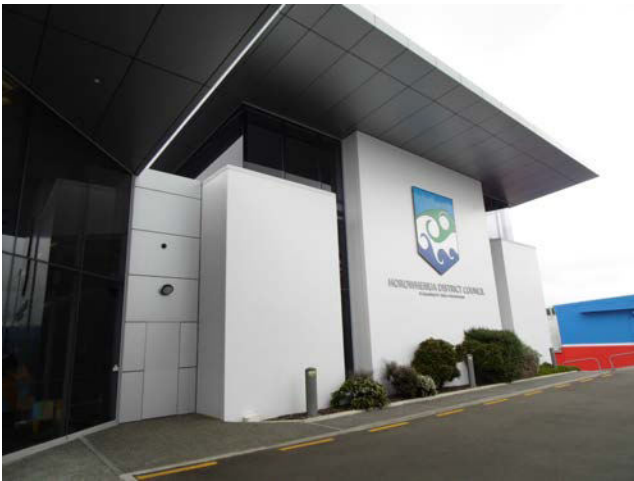
Photo 53

- 2.02.01 The front elevation of the Civic Building faces toward the north west with painted pre-cast panels forming the external finish together with full height aluminium joinery to the western end, beneath an aluminium composite panel soffit. The ground abuts the concrete panels and sections of membrane have been installed over the top of the pre-cast panels to act as weather protection (refer to Photos 53 and 54).

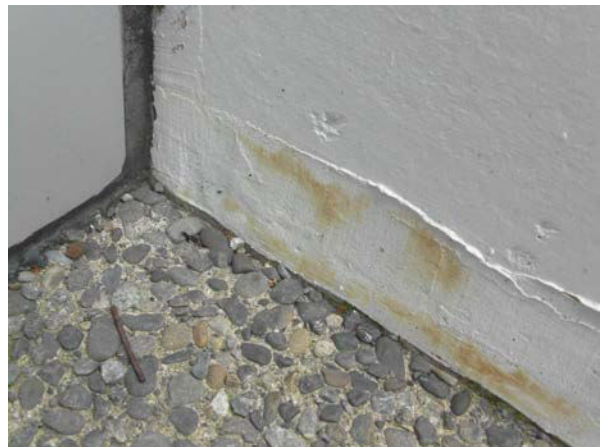
Photo 56

- 2.02.02 Where the paving provided adjacent to the entrance to the left of this section of the building is situated some corrosion staining is evident at the base of the pre-cast panels (refer to Photos 55 and 56). This suggests that moisture is holding in this location and may be seeping beneath the ground and possibly contributing to the moisture entry noted within the Basement from our internal inspection.

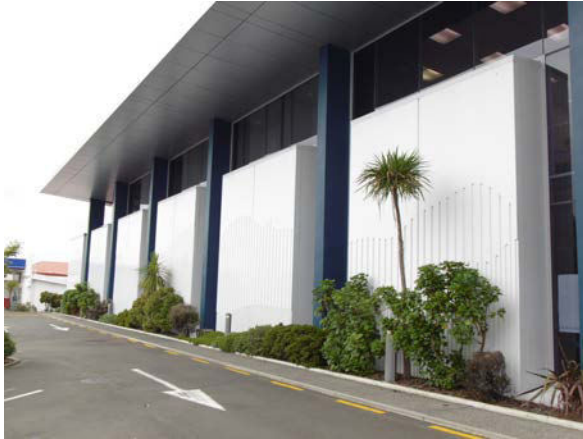
Photo 69

- 2.02.07 The gardens to the front of the north west facing elevation abut the pre-cast panels that form its construction (refer to Photos 69 and 70) and it is understood that the retaining section of this wall that forms the front wall of the Basement Car Park has been provided with a tanking system to prevent moisture ingress. A detailed inspection of the tanking system was not able to be undertaken without removing sections of the garden to confirm how this is applied at the top of the retaining section, but it is evident that moisture is penetrating and affecting the Basement Car Park from our internal inspection. It would be recommended therefore that some further investigation is undertaken to confirm how this has been detailed in order to prevent moisture entry at the junction with the floor slab where moisture appears to be penetrating from our internal inspection.

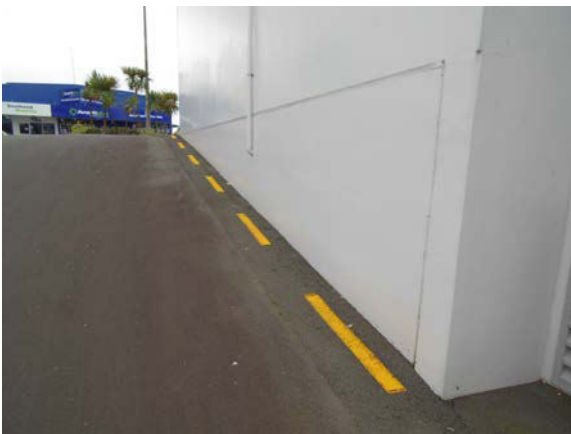
Photo 71

- 2.02.08 This is also a concern to the western end of the building where the road leading to the rear abuts the pre-cast panels (refer to Photo 71). In this position some moisture staining was noted to the panels at low level, which suggests that moisture is present behind the paint finish applied (refer to Photo 72) and this may therefore be penetrating behind the waterproofing and affecting the Basement Car Park.

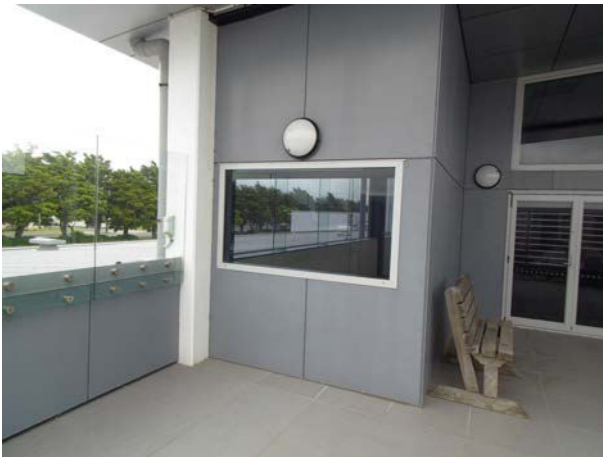
Photo 100

- 2.02.20 A further lack of clearance between the base of the façade panel cladding and the adjacent ground was noted where this cladding is used on the Terrace Mezzanine level (refer to Photos 99 – 101). The junction between the cladding and the adjacent tiles in that location is sealed with a sealant, which prevents any moisture that has penetrated behind the cladding from escaping.

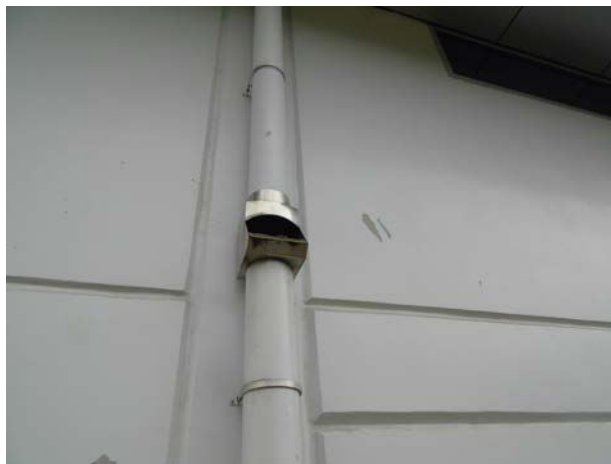
Photo 107

2.02.23 Deterioration of the coatings provided to the pre-cast panels was noted in a number of areas around the perimeter of the building where moisture had entered behind the coats. This was evident at high level and particularly adjacent to cracks where they have formed on the south west elevation, but also on the panels to the south east elevation (refer to Photos 106 – 108). It is considered therefore that the exterior of the building is due for the coating system provided to the pre-cast panels to be renewed.

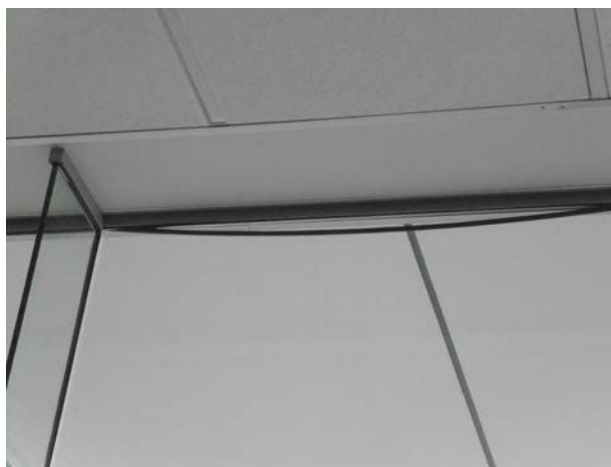
Photo 110

2.02.24 Our inspection also revealed that the glazing rubbers to a number of the windows to the Mezzanine level were loose and that these need to be reinstated or replaced where they have shrunk (refer to Photos 109 and 110).

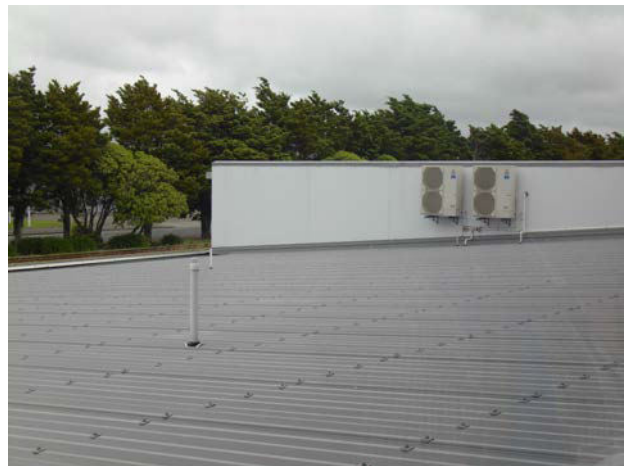
Photo 112

2.02.25 During our inspection we were unable to inspect the condition of the roof above the Mezzanine level or the Public Entrance Foyer due to lack of access and our inspection of the roof above the ground level accommodation was restricted to what could be seen from the Terrace and the Mezzanine level (refer to Photos 111 and 112). It is apparent that leaks through the internal gutter to the ground level roof have affected the interior at Office 136 and further investigation in respect of the repairs required in that position and also to prevent moisture entry affecting the Public Entrance Foyer would be recommended.
