Design Review and Post-Earthquake Assessment

Horowhenua District Council Building

126-148 Oxford St, Levin

Reference: 2788-8773

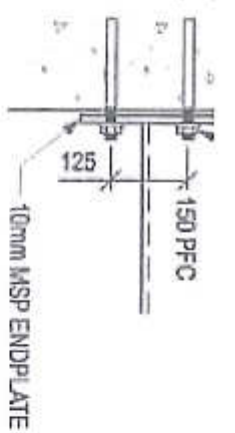
Diagram 15

Beam reinforcing unable
to take tension forces
in diaphragm

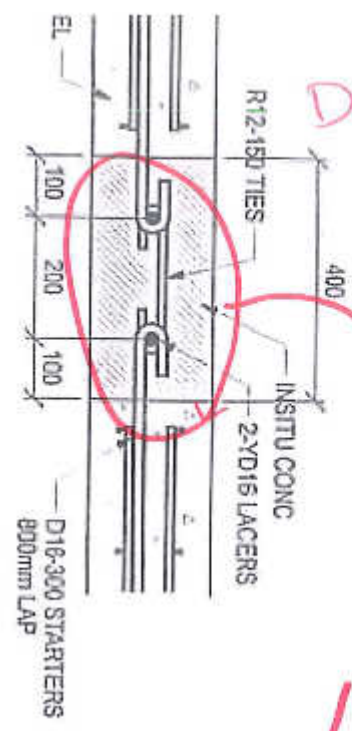
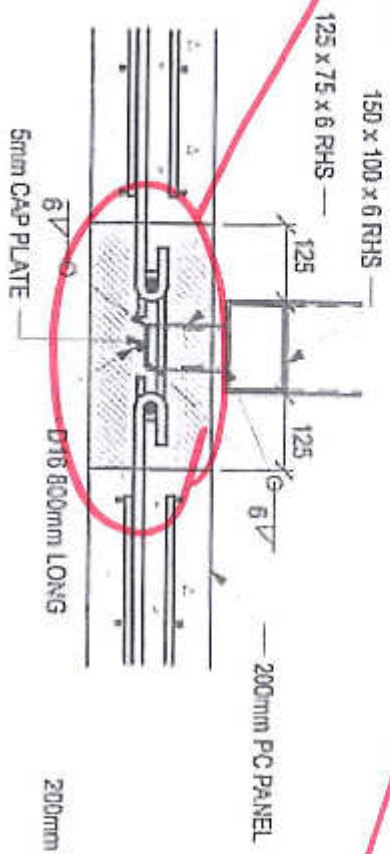
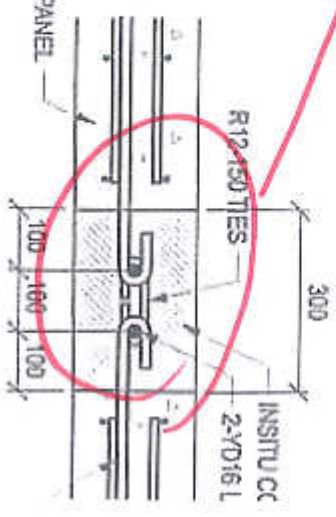
Diagram 17

No General continuity

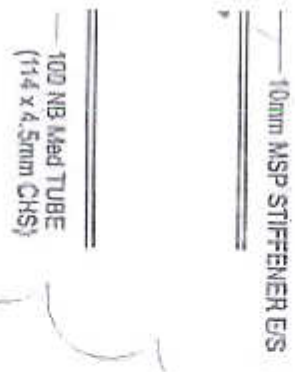
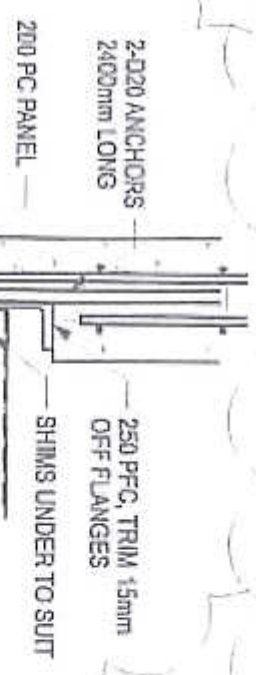
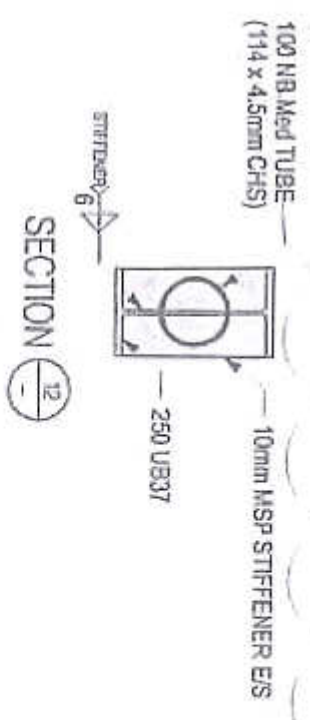
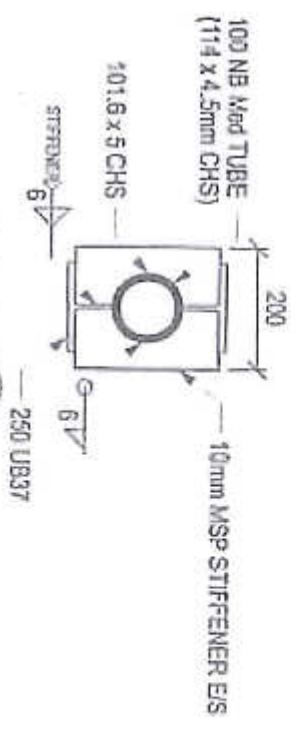
Diagram 18

The bracing at the high level between grids E and L have design issues due to the bracing being terminated away from the vertical brace element on the rafter. This will cause secondary stresses on the beams in their weak direction and becomes the governing strength of the system which has strengths less than that required by the compliance documents at the time. (See Appendix A, Diagram 18)
